# **INVESTIGATING THE CAUSES OF FIRE**

Causes and dynamics of the multiple explosion occurred in the tank park of a plant that processed raw pomace oil to get edible olive oil

**Loris MUNARO - Luca MARMO**  
**Norberto PICCININI - Paola RUSSO – Gennaro RUSSO**

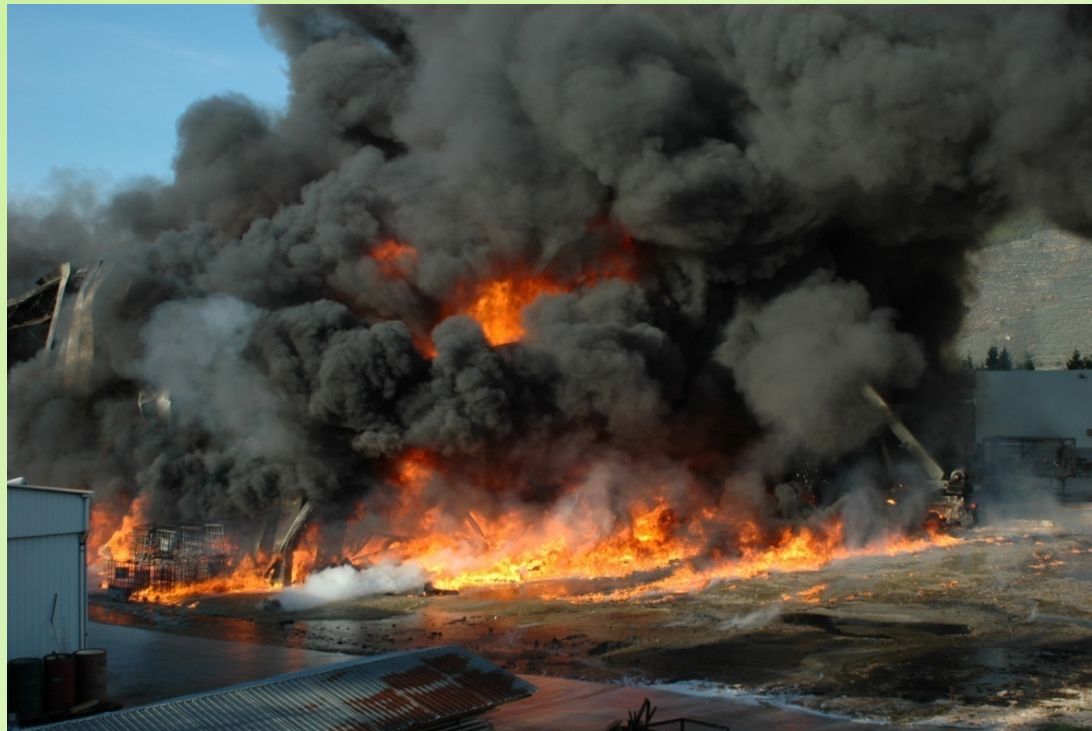
The reservoirs content poured into the tank park, the pool fire further spread, also involving the indoor tank park causing the collapse of the tanks 77 to 88.

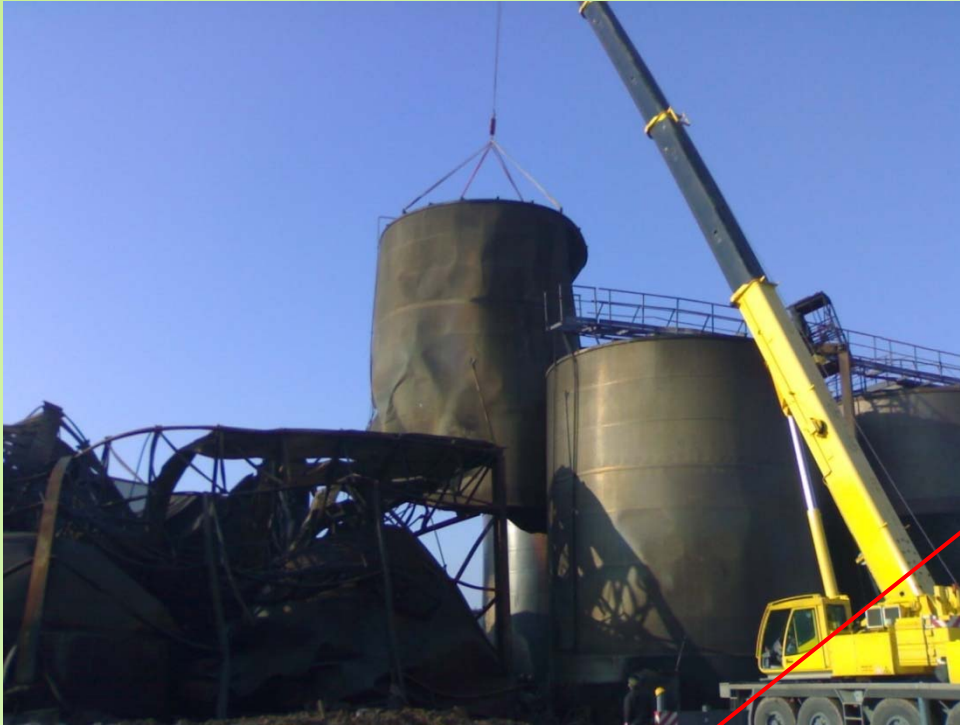
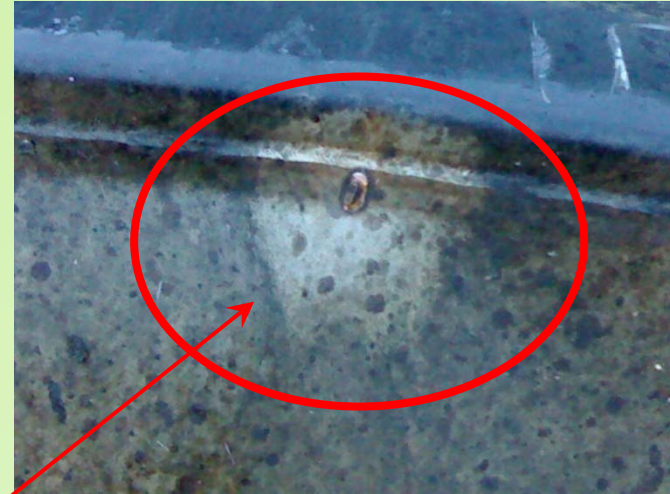
Tank # 95: Weld bead on top of the tank (outside).

Overheating (at least 750 °C) fingerprint inside the tank.

One worker found still holding the clamp of the welding machine

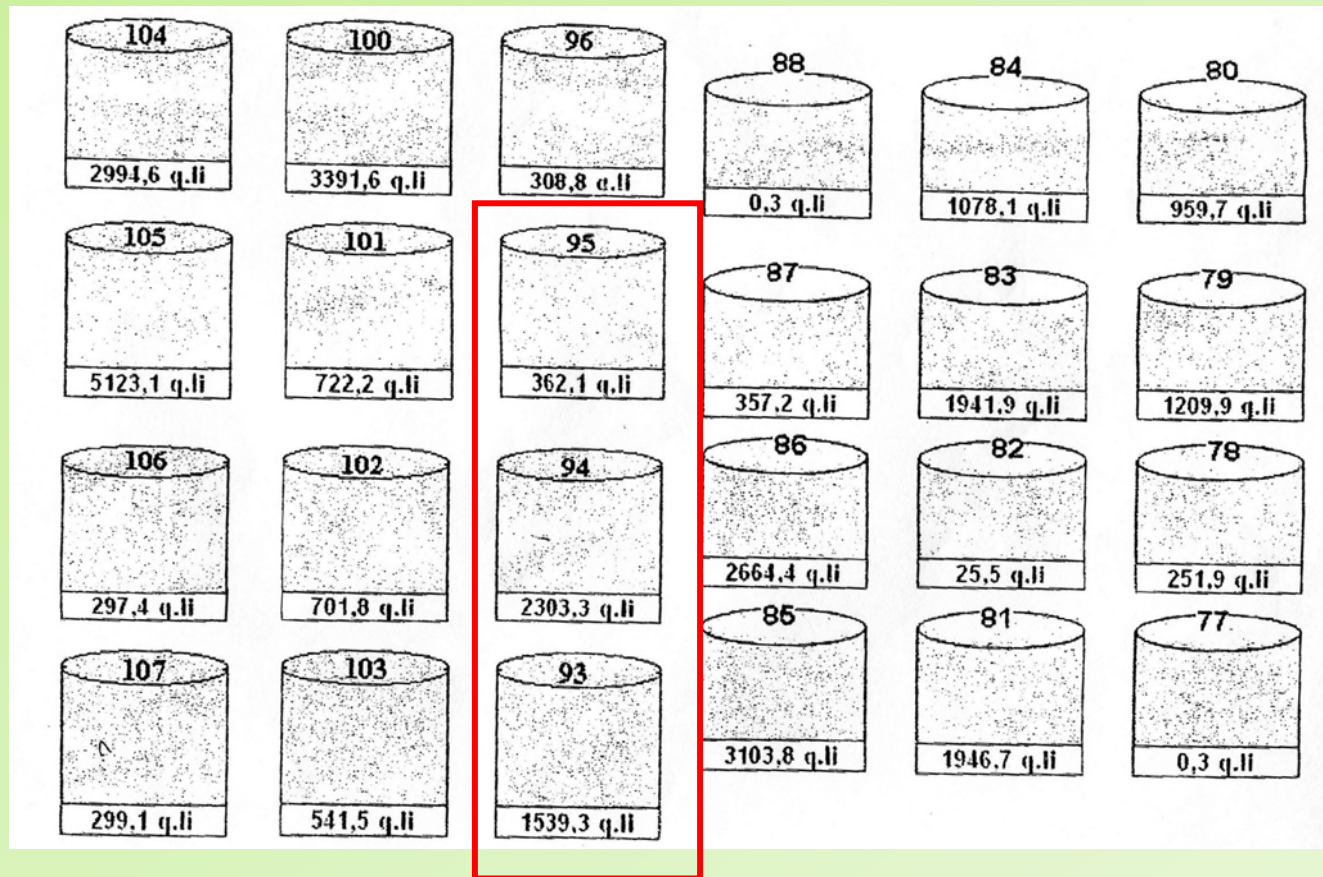
Oil content (figure from control system)

Oil quality: N° 93, 94, 95, 86 and 103: raw pomace oil, tanks N°96, 100, 87, 89: refined oil, tanks N°101-102 and 104-107: lamp oil

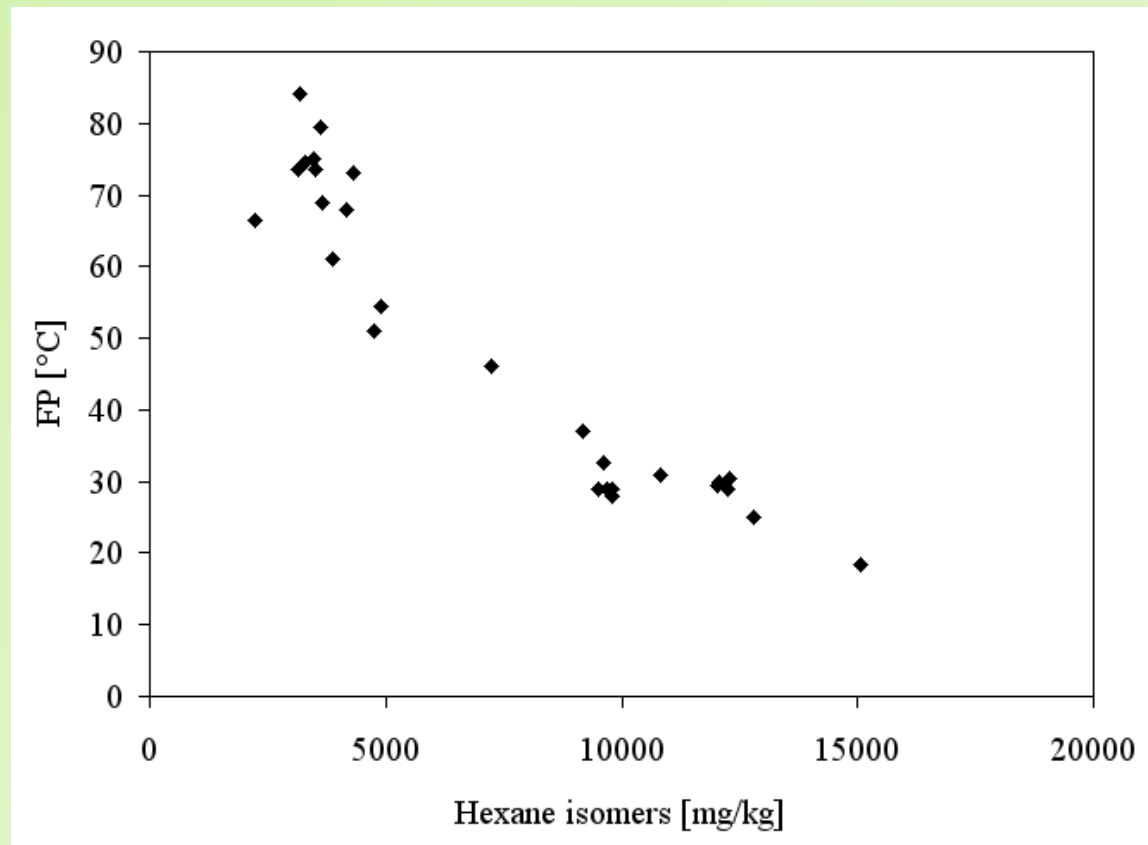
The lowest FP was 18,5 °C. More than 20% of the samples had  $FP \leq 60$  °C )

FP of oil contained in tank 95 was 29 °C

Average ambient temperature  $\approx 10$  °C

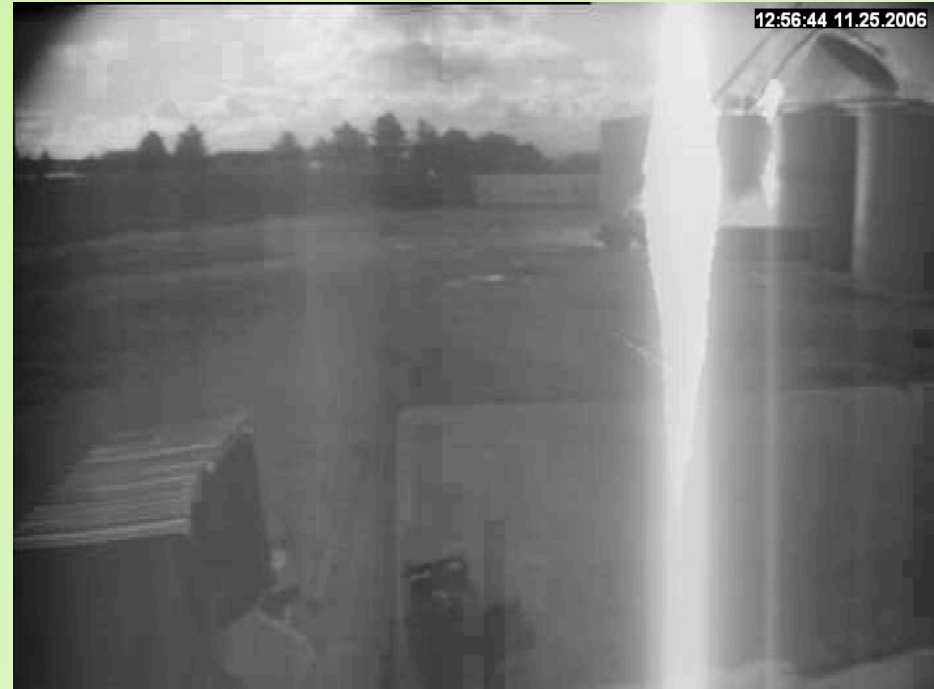
No explosion occurred in tank N°  
95

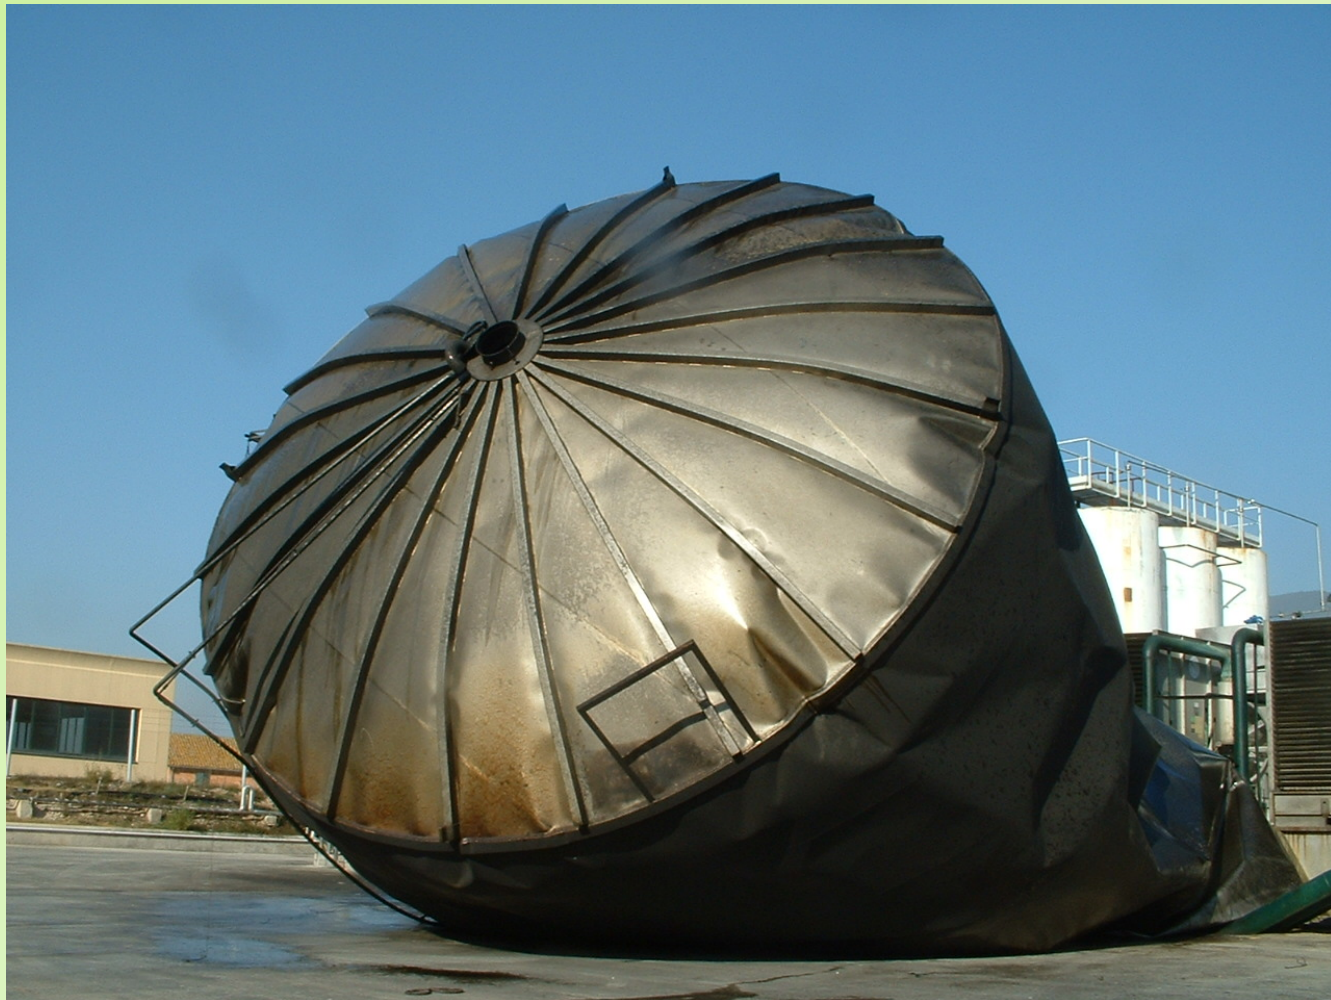
Tank # 94:

Explosion inside: Roof clearly deformed, Manhole opened

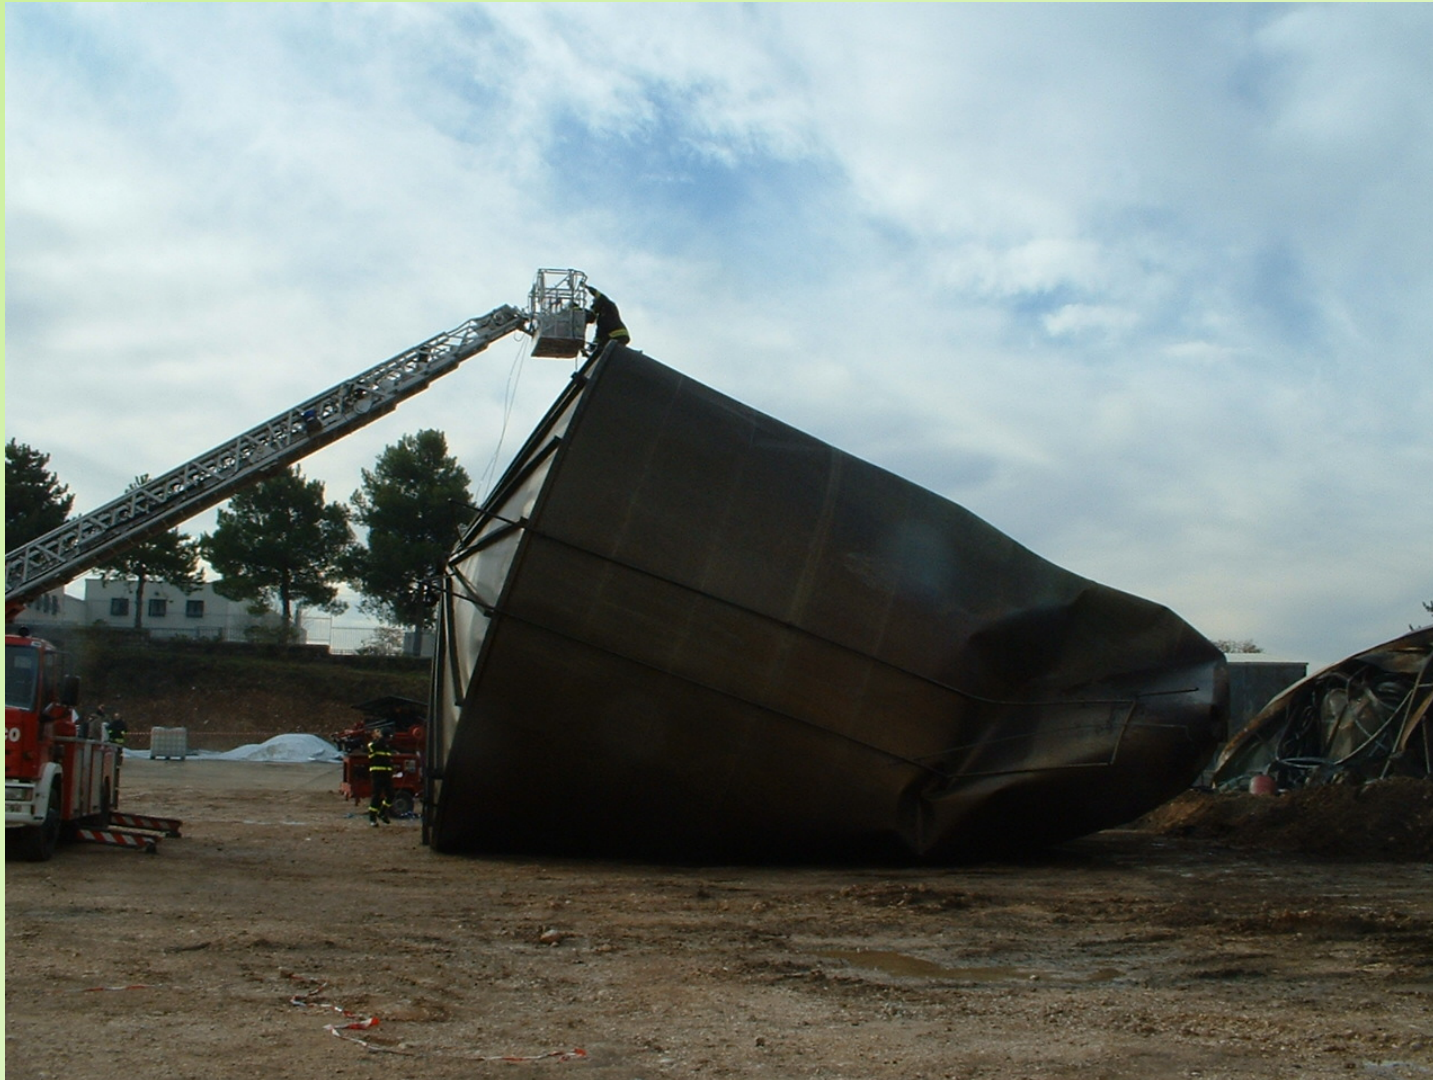
Tank # 95

No deformation of the tank roof

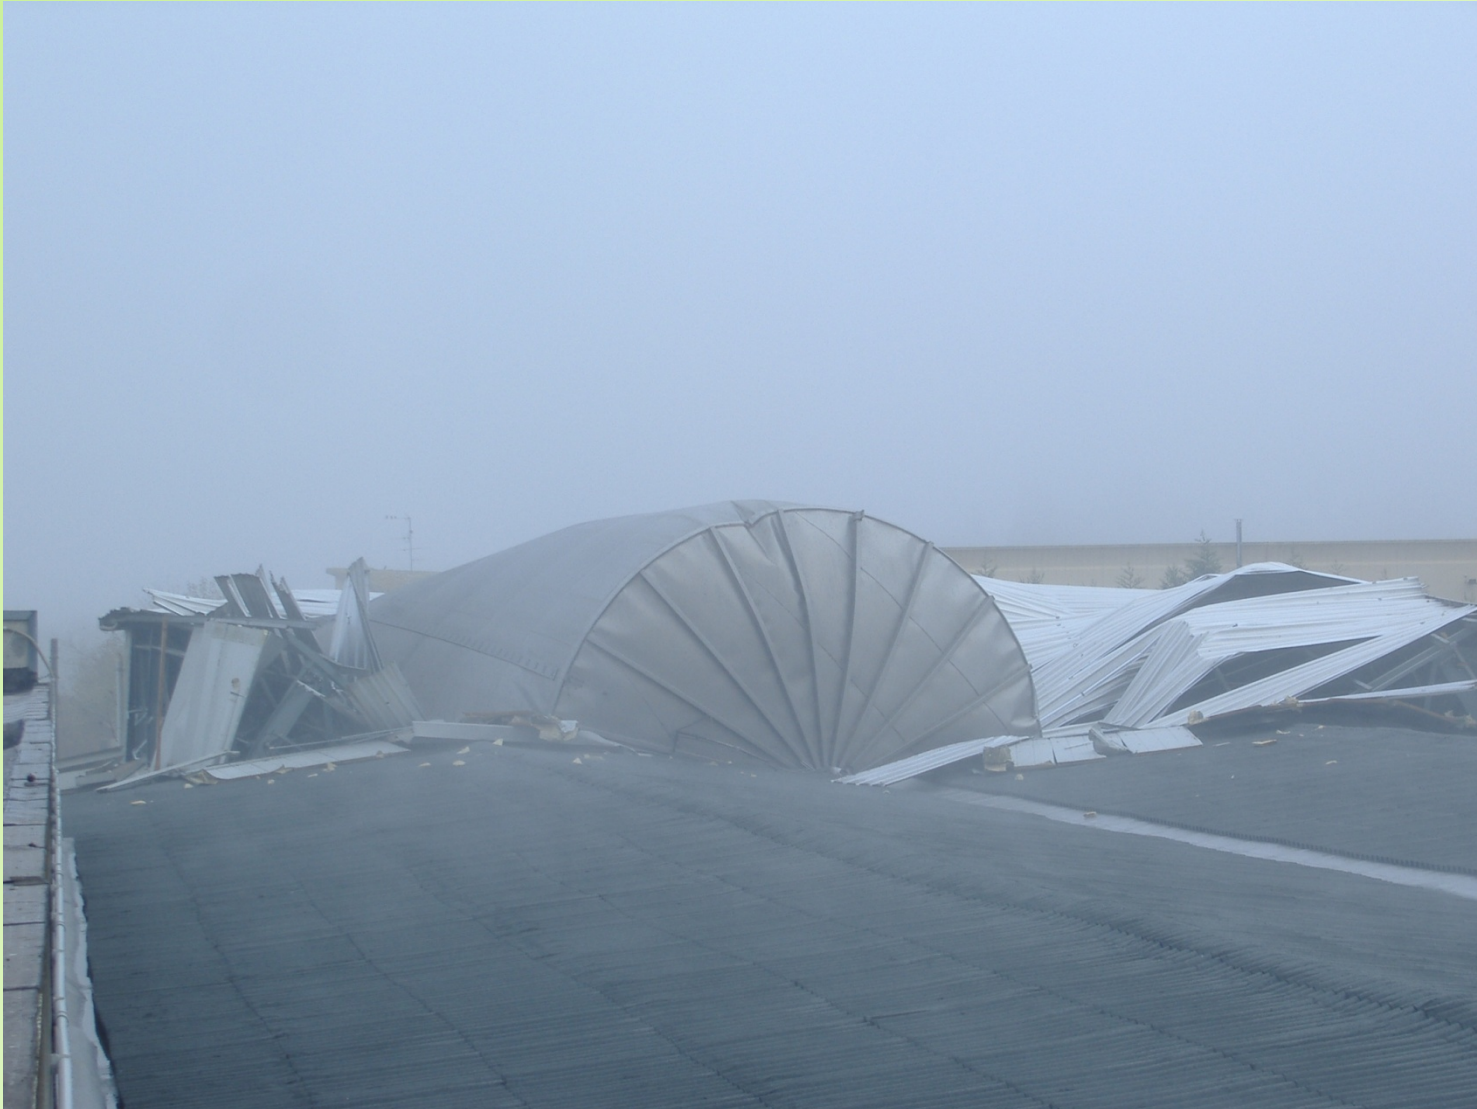
Tank N° 93

Roof clearly deformed

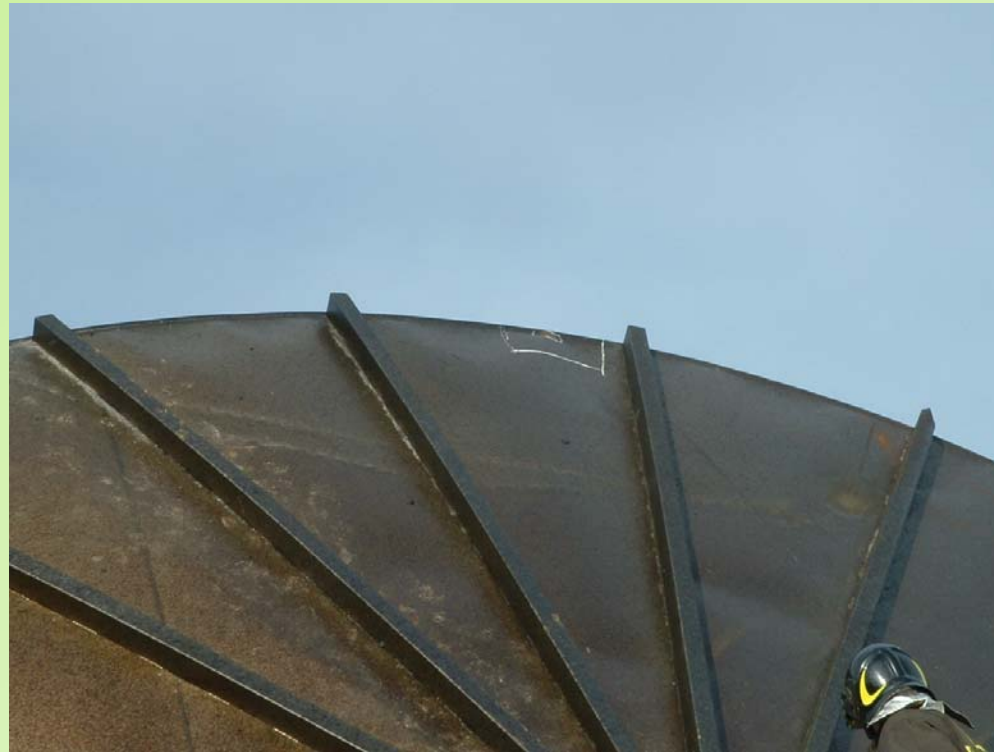
Tank # 95

No deformation of the tank roof

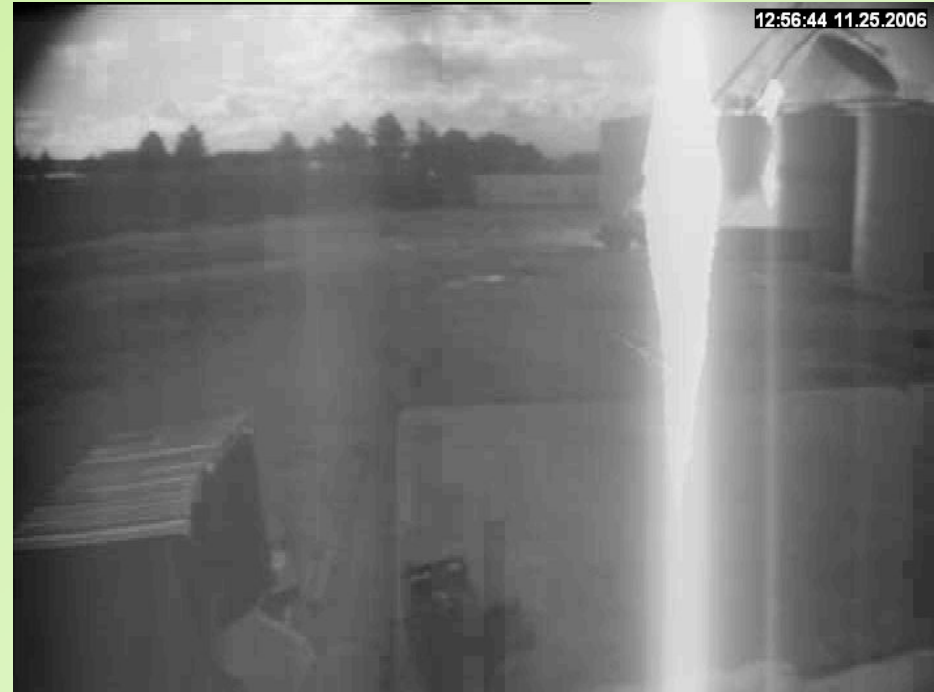
No explosion occurred in tank # 95

*“before the tank lifts no welding activity is visible;  
one can see the four chains to which  
is attached the catwalk  
when the tank tilts no blaze or smoke  
is visible above, where the tank is  
opened;  
the first blaze is at the bottom;  
the crane operator at ground level can  
not see neither the hook nor what the  
work mates they are doing and,  
without radio communications, the  
operation is blind”*

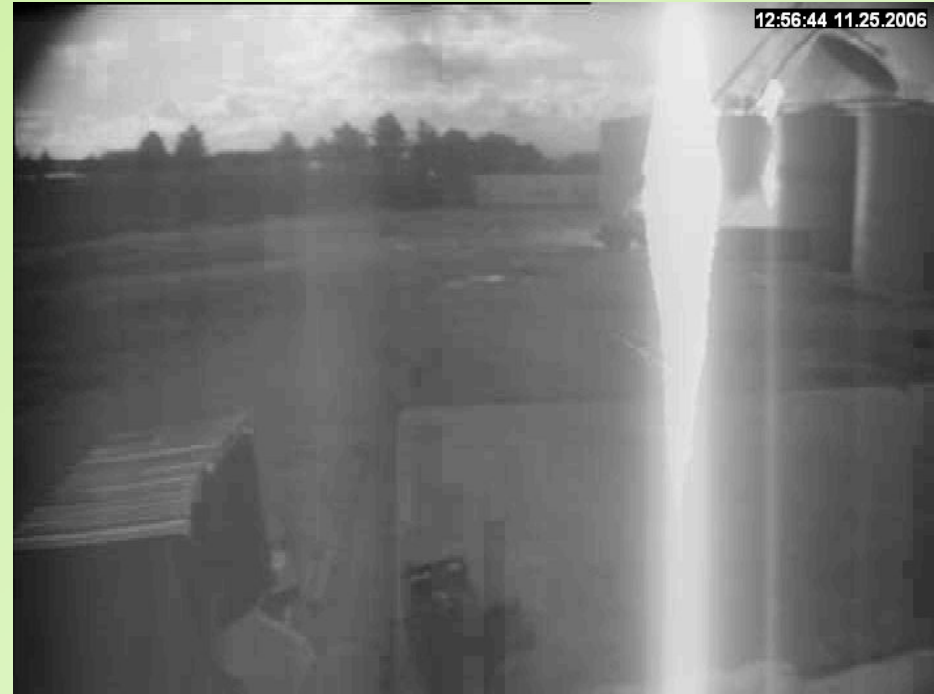
No explosion occurred in tank # 95

*“before the tank lifts no welding activity is visible;  
one can see the four chains to which  
is attached the catwalk  
when the tank tilts no blaze or smoke  
is visible above, where the tank is  
opened;  
the first blaze is at the bottom;  
the crane operator at ground level can  
not see neither the hook nor what the  
work mates they are doing and,  
without radio communications, the  
operation is blind”*
