INVESTIGATING THE CAUSES OF FIRE

Fire Ignition Analysis on Photovoltaic Roof and Related Buildings

Vincenzo PUCCIA

Fire Investigation after two major Fire events

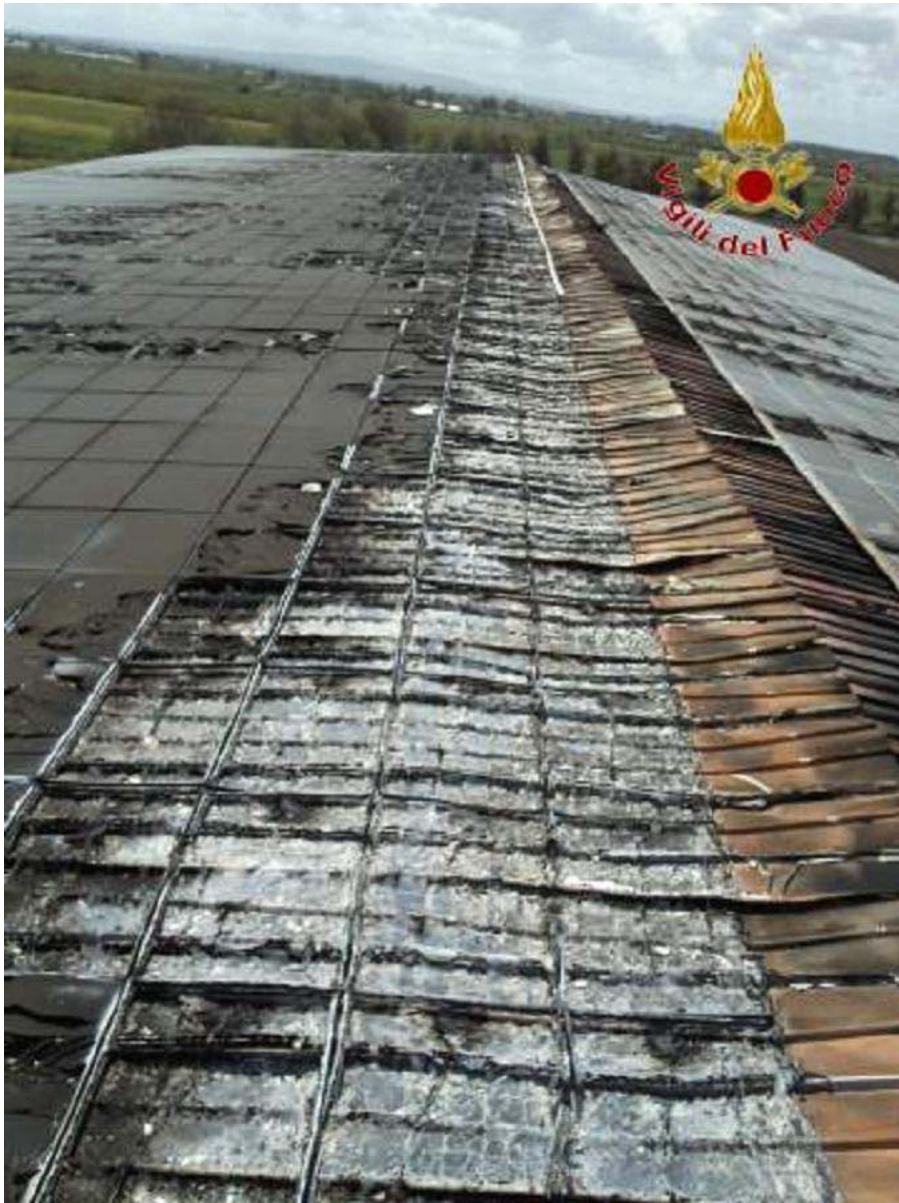
- Combustible insulating foam ignition
- An initial smoldering combustion
- Pyrolysis rate increases as air leaks inside the PU sandwich Panel
- The cover and the plant resulting totally destroyed
- smoke leaking inside the compartment
- Ignition of a lower fire compartment

- Polyurethane (PU) core material is considered to be the best material in keeping warm and thermal insulation, but is easily ignitable, and if a fire starts from a PV module or an electric board, it easily spreads out on the roof – **also favored by the wind action** – through the PU core of the cover sandwich panels.

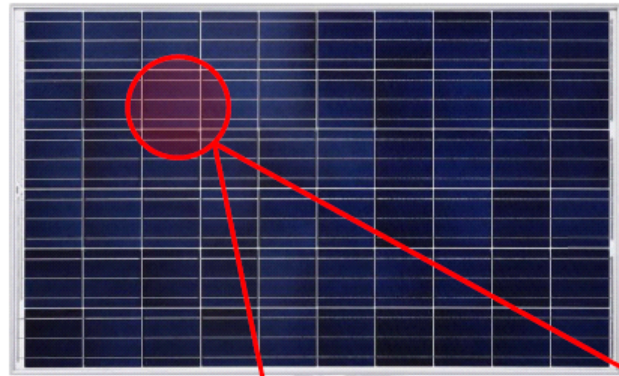
An incorrect soldering between ribbons could lead to localised overheating.

An HOT SPOT could be generate

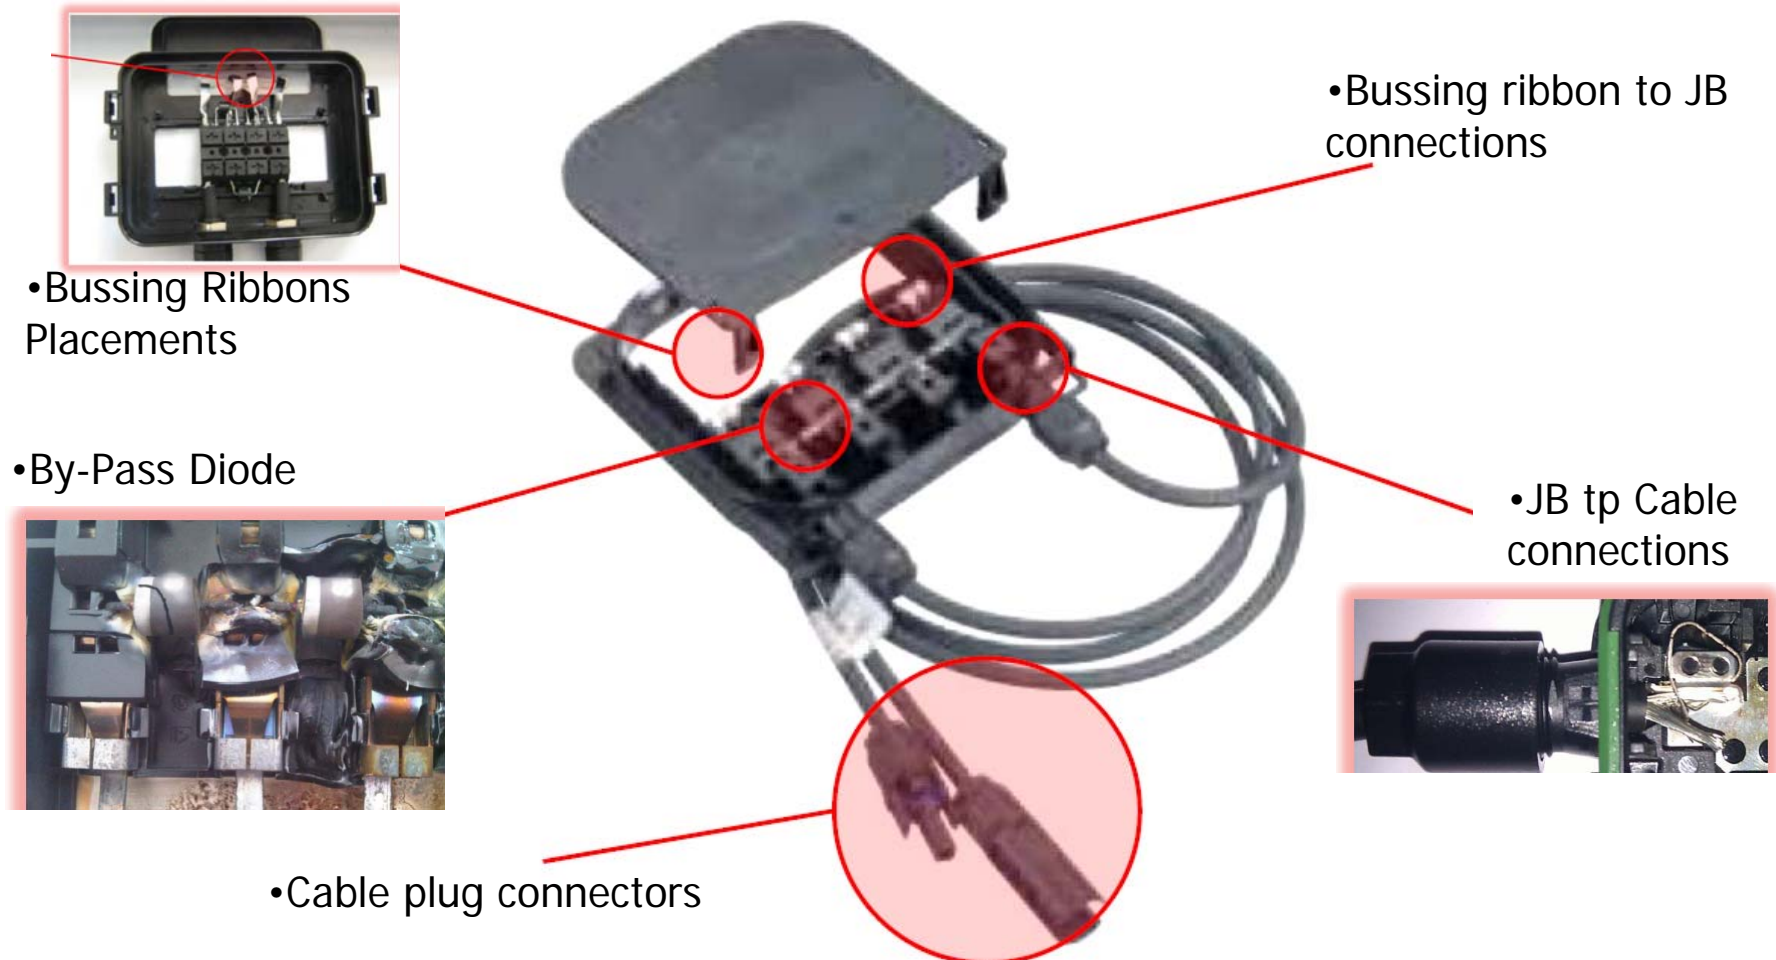
IF JB placements is poor, lack in distances between positive and negative voltage could lead to a parallel DC ARC
