ABRUZZO THE EARTHQUAKE IN L'AQUILA

Itinerary among the most significant buildings damaged by the earthquake

Itinerary among the province sites damaged by earthquake

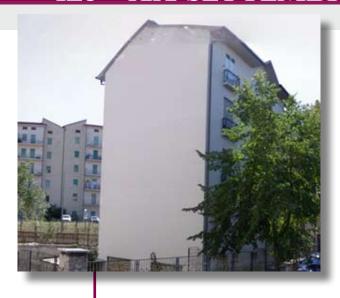
123 XX SETTEMBRE STREET

quake damage

Collapse
of reinforced
concrete pillars
and ceilings,
followed by the
collapse of the
entire structure.

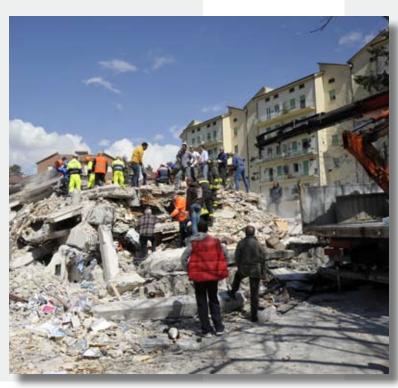
STUDENT'S LODGING

quake damage

Collapse of a wing of the building.
Extensive damage to the other wing.

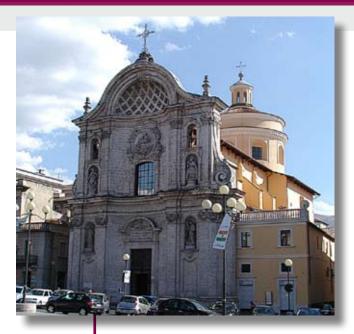
CHURCH OF S. MARIA DEL SUFFRAGIO

Collapse of drum, dome and lantern.
Collapse of projections such as veil, spire, pinnacles, etc. Extensive damage to the triumphal arch. Extensive damage, near to the collapse, to roofing elements of presbytery and apse.

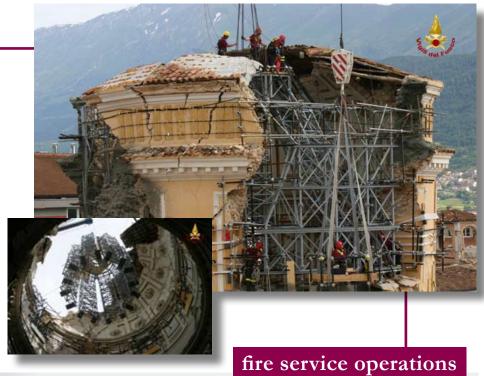
quake damage

Recovery of important works of art dating back to the 17th and 18th century. Thanks to advanced laser technology, it was possible to develop a restoration project for the collapsed sections of the dome by using steel trusses. The SAF (high angle rescue) teams installed reinforcement rings around the dome, in order to prevent further structural detachments, and strengthened the drum windows. After these preliminary safety measures were taken, it was possible to install the "spider", a metal structure with eight extendable arms, inside the dome.

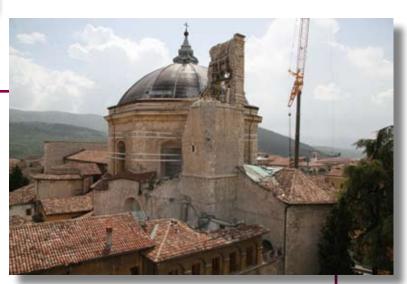
CHURCH OF SAN BERNARDINO

quake damage

Collapse of belfry, extensive damage to dome drum. Severe cracks in the apse and on longitudinal walls. Cracks also in the adjacent convent and barracks.

The fire-fighters also removed the relics of the Saint, who was buried in the church in 1444. Later the church was secured by means of provisional measures and the only wall of the bell tower left standing was shored up with wooden props.

The dome drum was strengthened by reinforcement rings. Parts of columns and stones fallen on the roof of the adjacent convent were recovered for future restoration work.

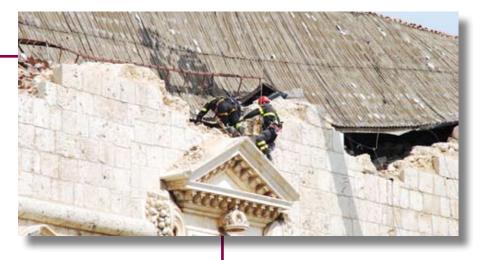
SPANISH FORTRESS

quake damage

Partial collapse
of ceilings and
of entrance wall top.
Severe cracks on vertical
walls, overturning
of open gallery and ground
floor pilasters. Extensive
damage to the collections
of the National Museum
of Abruzzo.

Removal of the collections of the National Museum. Securing of the more damaged sections of the castle by means of steel tie beams (i.e. the entrance wall and the imposing inner open gallery).

Cranes able to lift 100 tons were used to install heavy steel beams and to remove unsafe sections of a reinforced concrete roof.

In order to ensure safe access to inner premises during future restoration works, wooden containment structures – called tortoise - were built.

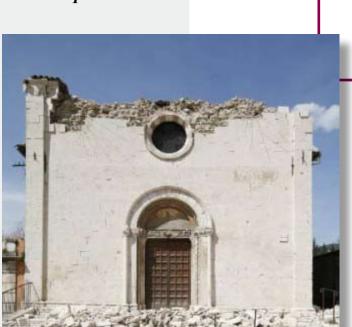
CHURCH OF SAN VITO ALLA RIVERA

quake damage

Collapse of the top of façade and overturning at the top.

The church destroyed by the tremor. Above: the fire-fighters covering the roof of the church and a detail of the sundial. At the top: the Church of San Vito before the earthquake.

Recovery of collapsed façade elements and detachment of unsafe sections.

The damaged roof was protected with a waterproof covering, to prevent rain damage.

Due to the value of the sundial engraved in the stone, all fragments were carefully numbered to allow the sundial's restoration.

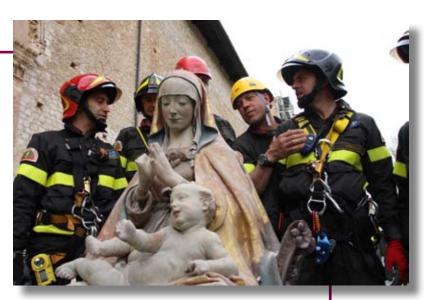
CHURCH OF S. M. OF COLLEMAGGIO

quake damage

Collapse of transept vaults, triumphal arches, drum, dome and transept roof. Extensive damage, near to collapse, to presbytery, apse and related roof elements. Moderate damage to bell tower and projections.

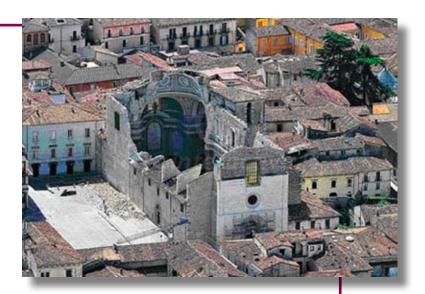
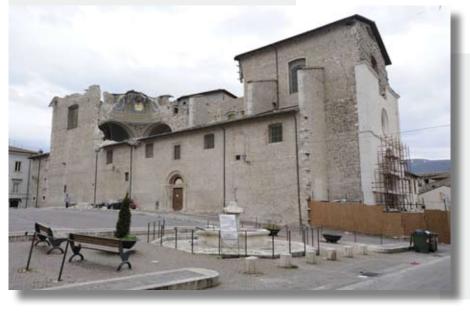
CHURCH OF S. MARIA PAGANICA

quake damage

Collapse of dome and drum, collapse of the vaults of the chapels. Collapse of side wall roofs. Collapse of architectural elements of the hall. Extensive damage, near to collapse, to the top of façade. Severe cracks in the central nave and side aisles. Severe cracks in the triumphal arches and in the apse. Detachment of façade from side walls and overturning at the top.

Removal of all works of art inside the church. Recovery and classification of the fallen ashlars belonging to the main portal. Securing of the top section of the left corner with polyester bands.

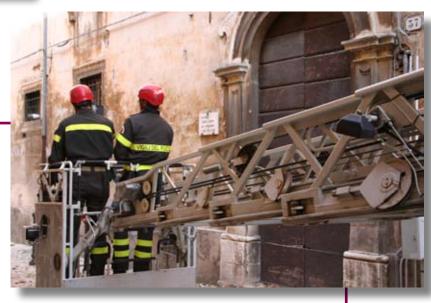
ARDINGHELLI PALACE

quake damage

Extensive damage to bearing structures.
Severe cracks and partial collapse of façade projections and decorations.

Recovery and classification of cut stone fragments fallen from the main balcony. The area surrounding the palace has been cordoned off.

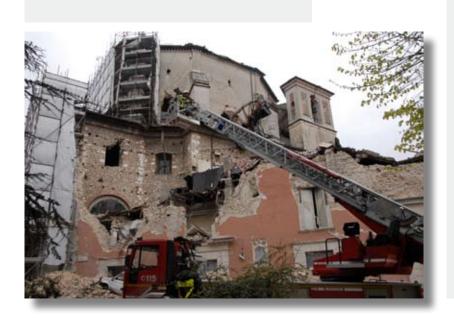
CHURCH OF SANT' AGOSTINO

quake damage

Collapse of the lantern. Extensive damage, near to collapse, to the dome. Severe cracks on longitudinal walls and on the façade. The precious works of art inside the church were damaged as well.

The SAF (high angle rope rescue) teams secured the dome by means of steel reinforcement rings, strengthened the belfry veil and removed the unsafe sections of the lantern which still hung ominously over the building beneath.

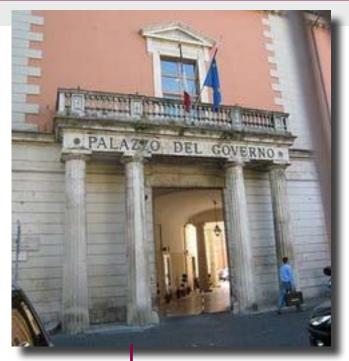
PREFECTURE PALACE

The building collapsed except for the ground floor, also seriously damaged

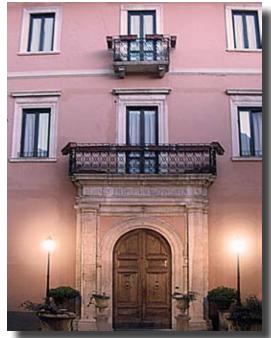
SAN MASSIMO CATHEDRAL AND ARCHBISHOP'S PALACE

Severe cracks on the hall and side aisle vaults. Severe cracks on the vaults of the side walls and in the apse

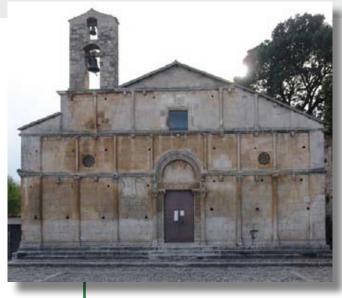
SANTA GIUSTA IN BAZZANO

Collapse of the top of façade, overturning of façade top and side walls. Partial collapse of the roof, severe cracks in vault arches, cracks in the pillars, damaged frescoes.

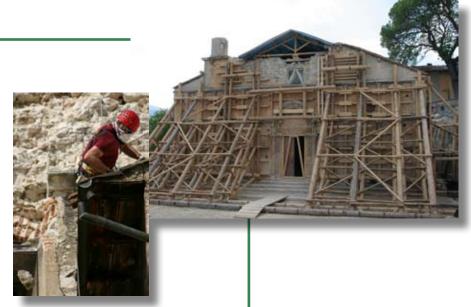
quake damage

The Fire Service teams, after having recovered fallen cut stone work and detaching the unsafe ones, carried out significant provisional measures in order to secure the building.

Shoring of the façade and side walls, centering of nave arches and hooping of pilasters.
