# **INVESTIGATING THE CAUSES OF FIRE**

Causes and dynamics of the multiple explosion occurred in the tank park of a plant that processed raw pomace oil to get edible olive oil

**Loris MUNARO - Luca MARMO**  
**Norberto PICCININI - Paola RUSSO – Gennaro RUSSO**

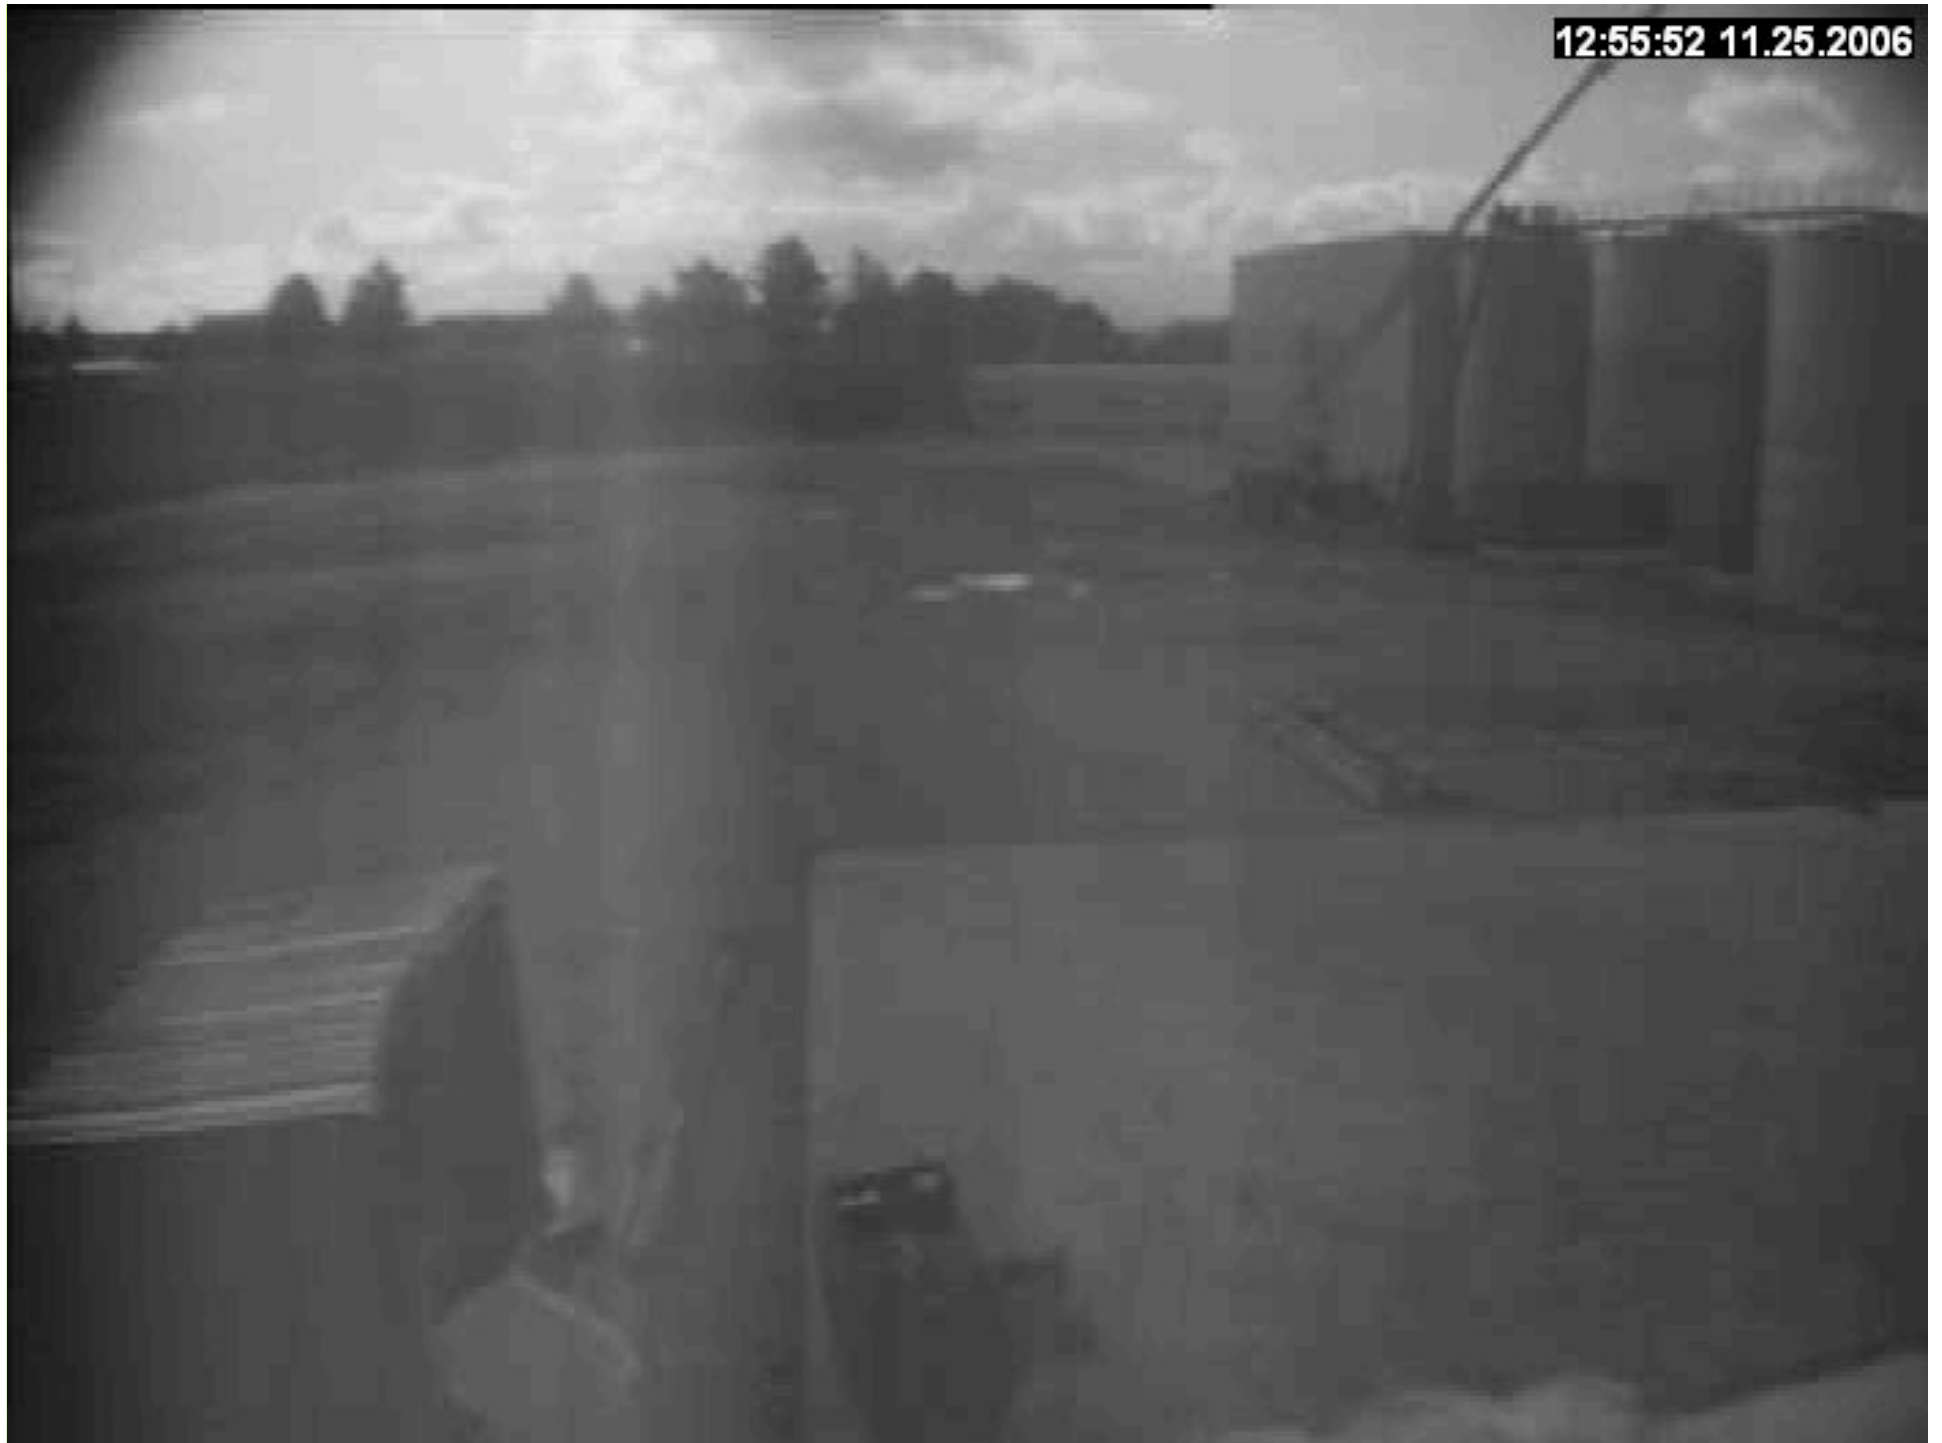
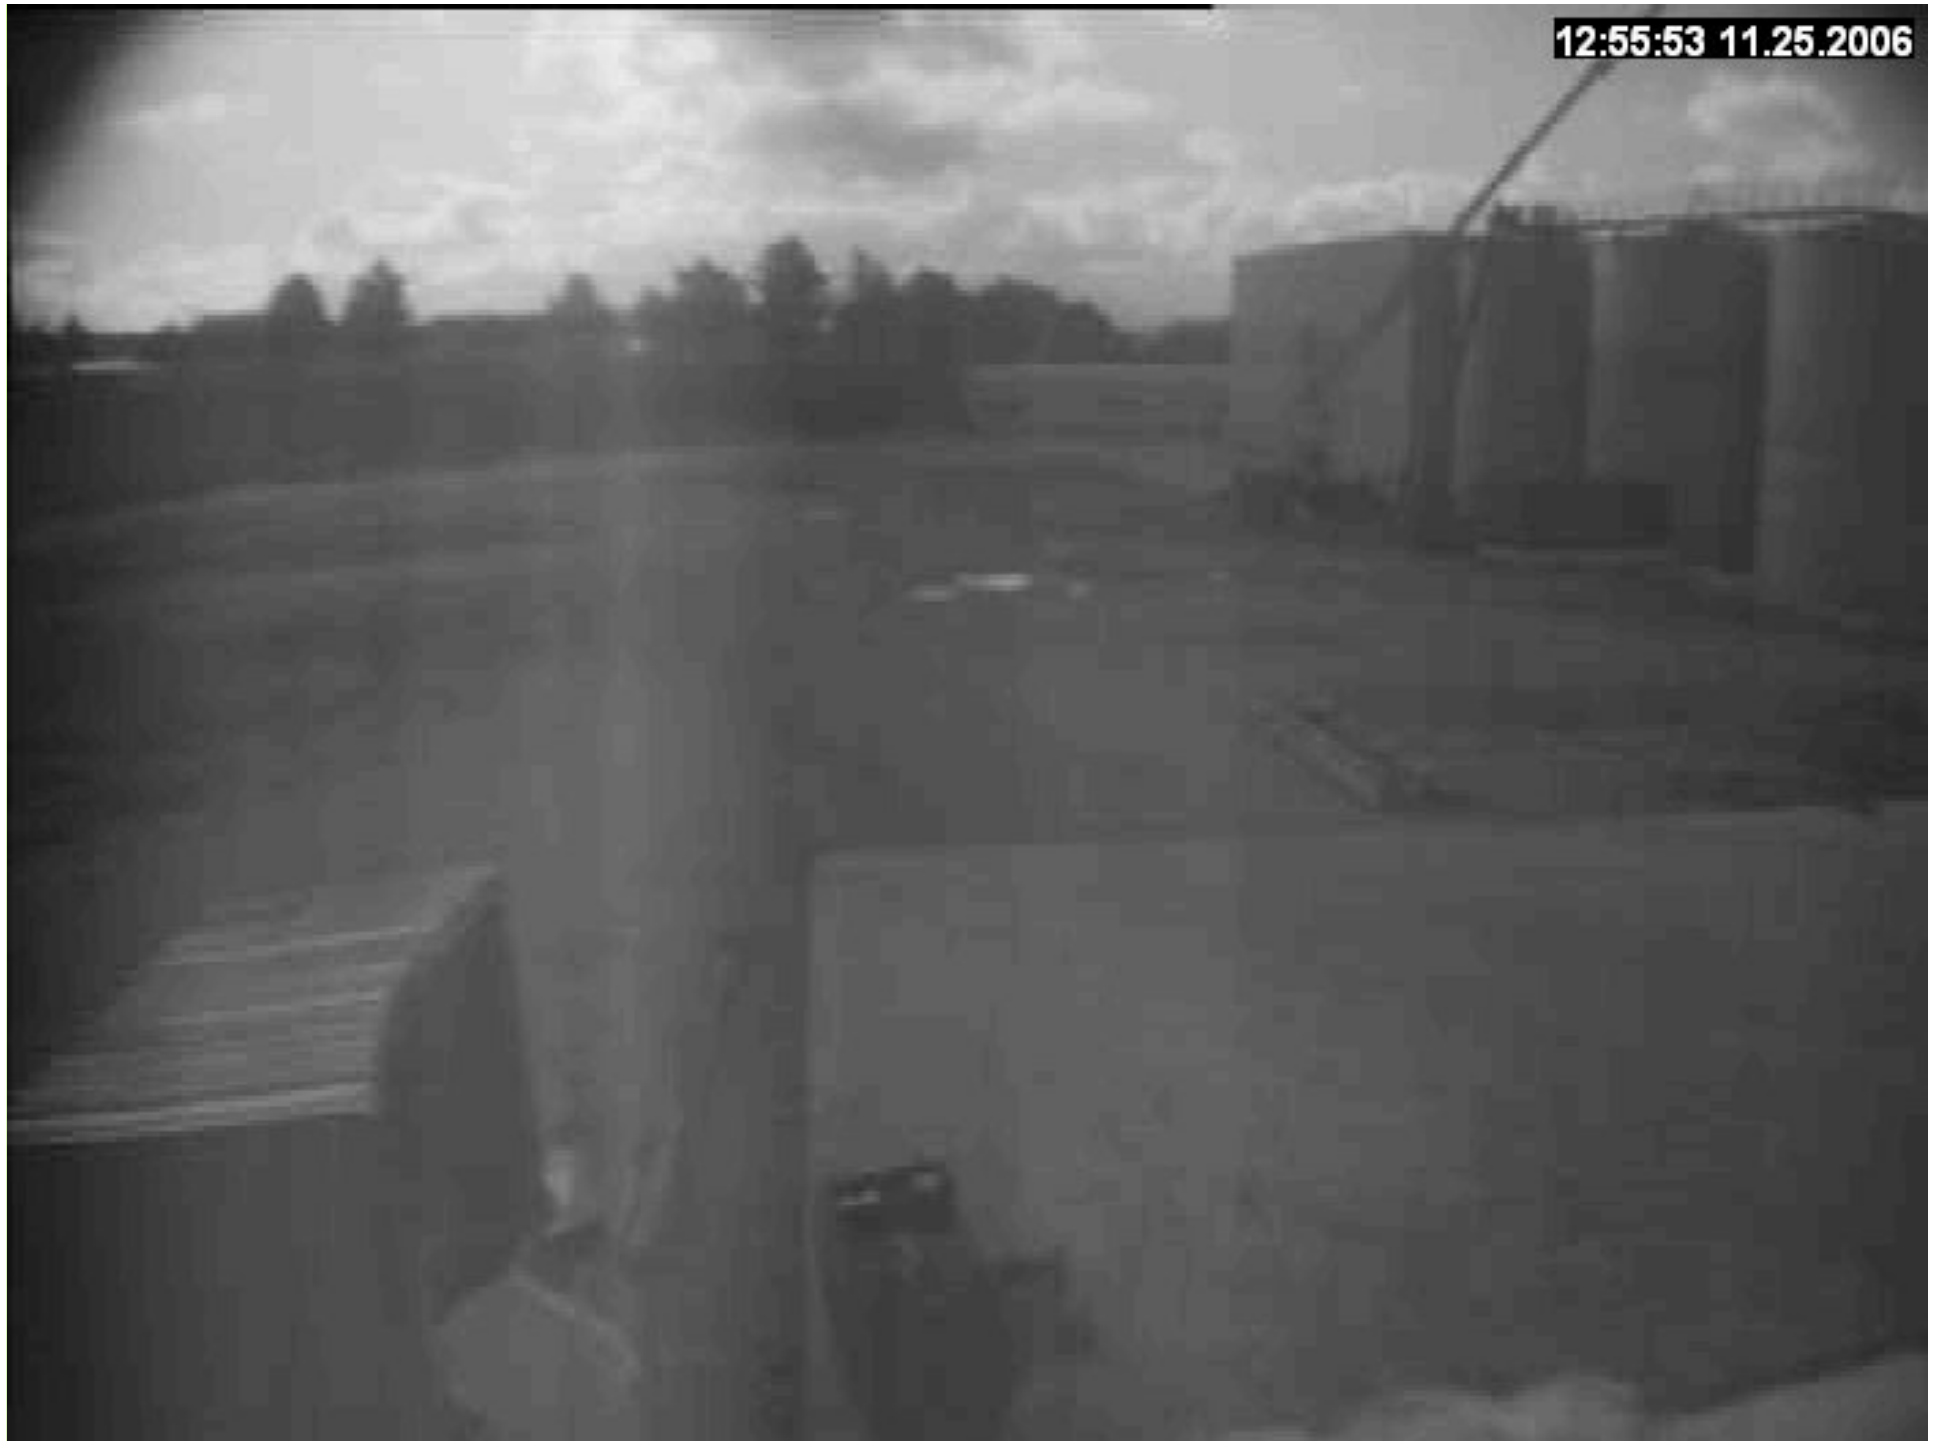
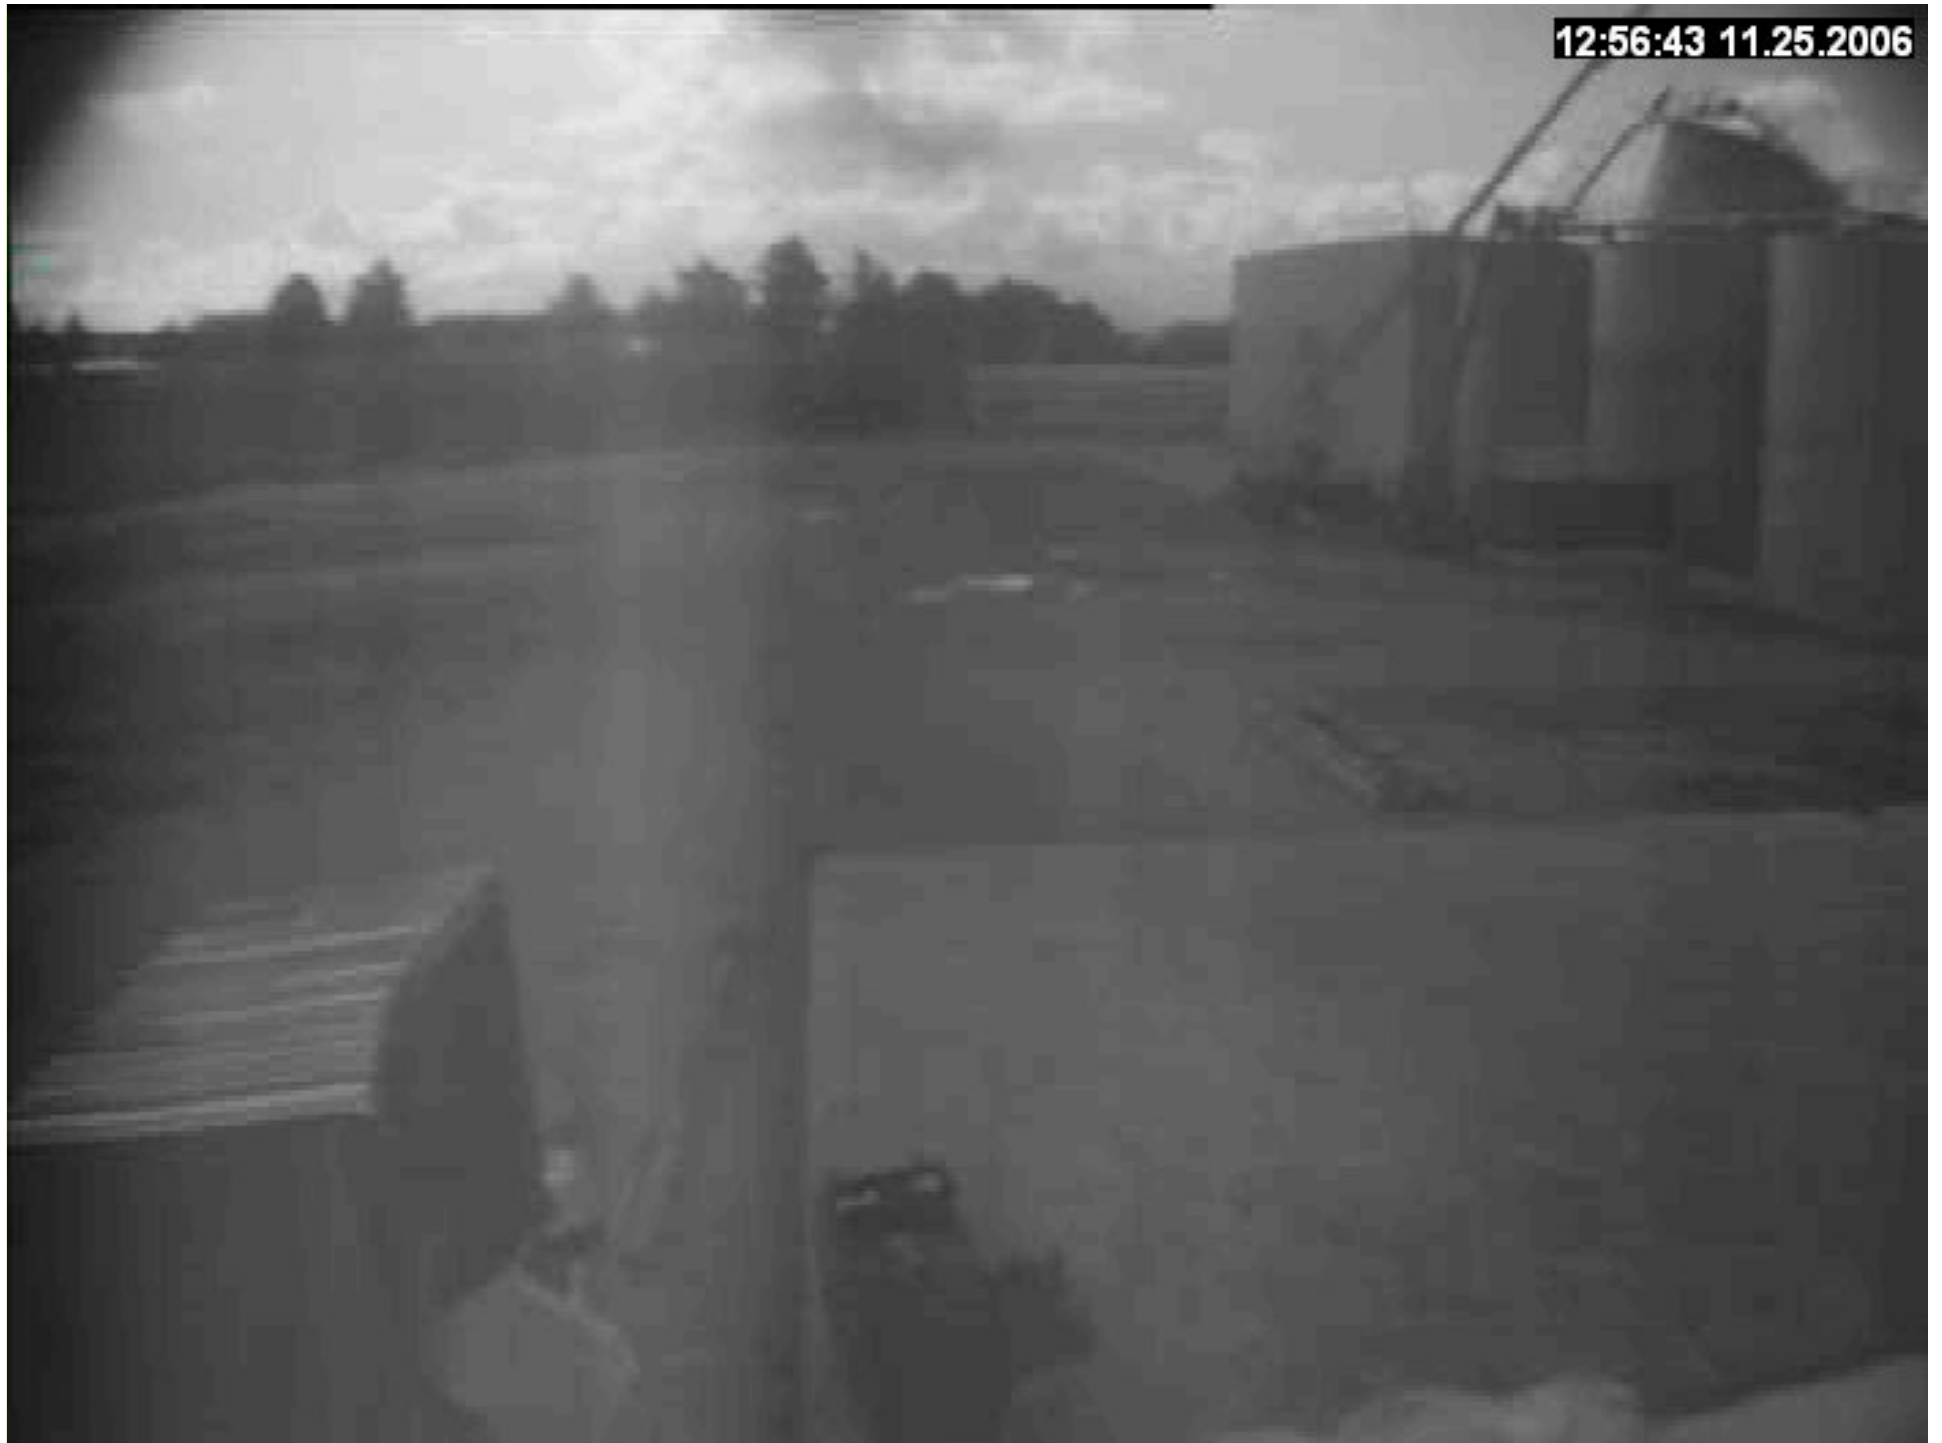
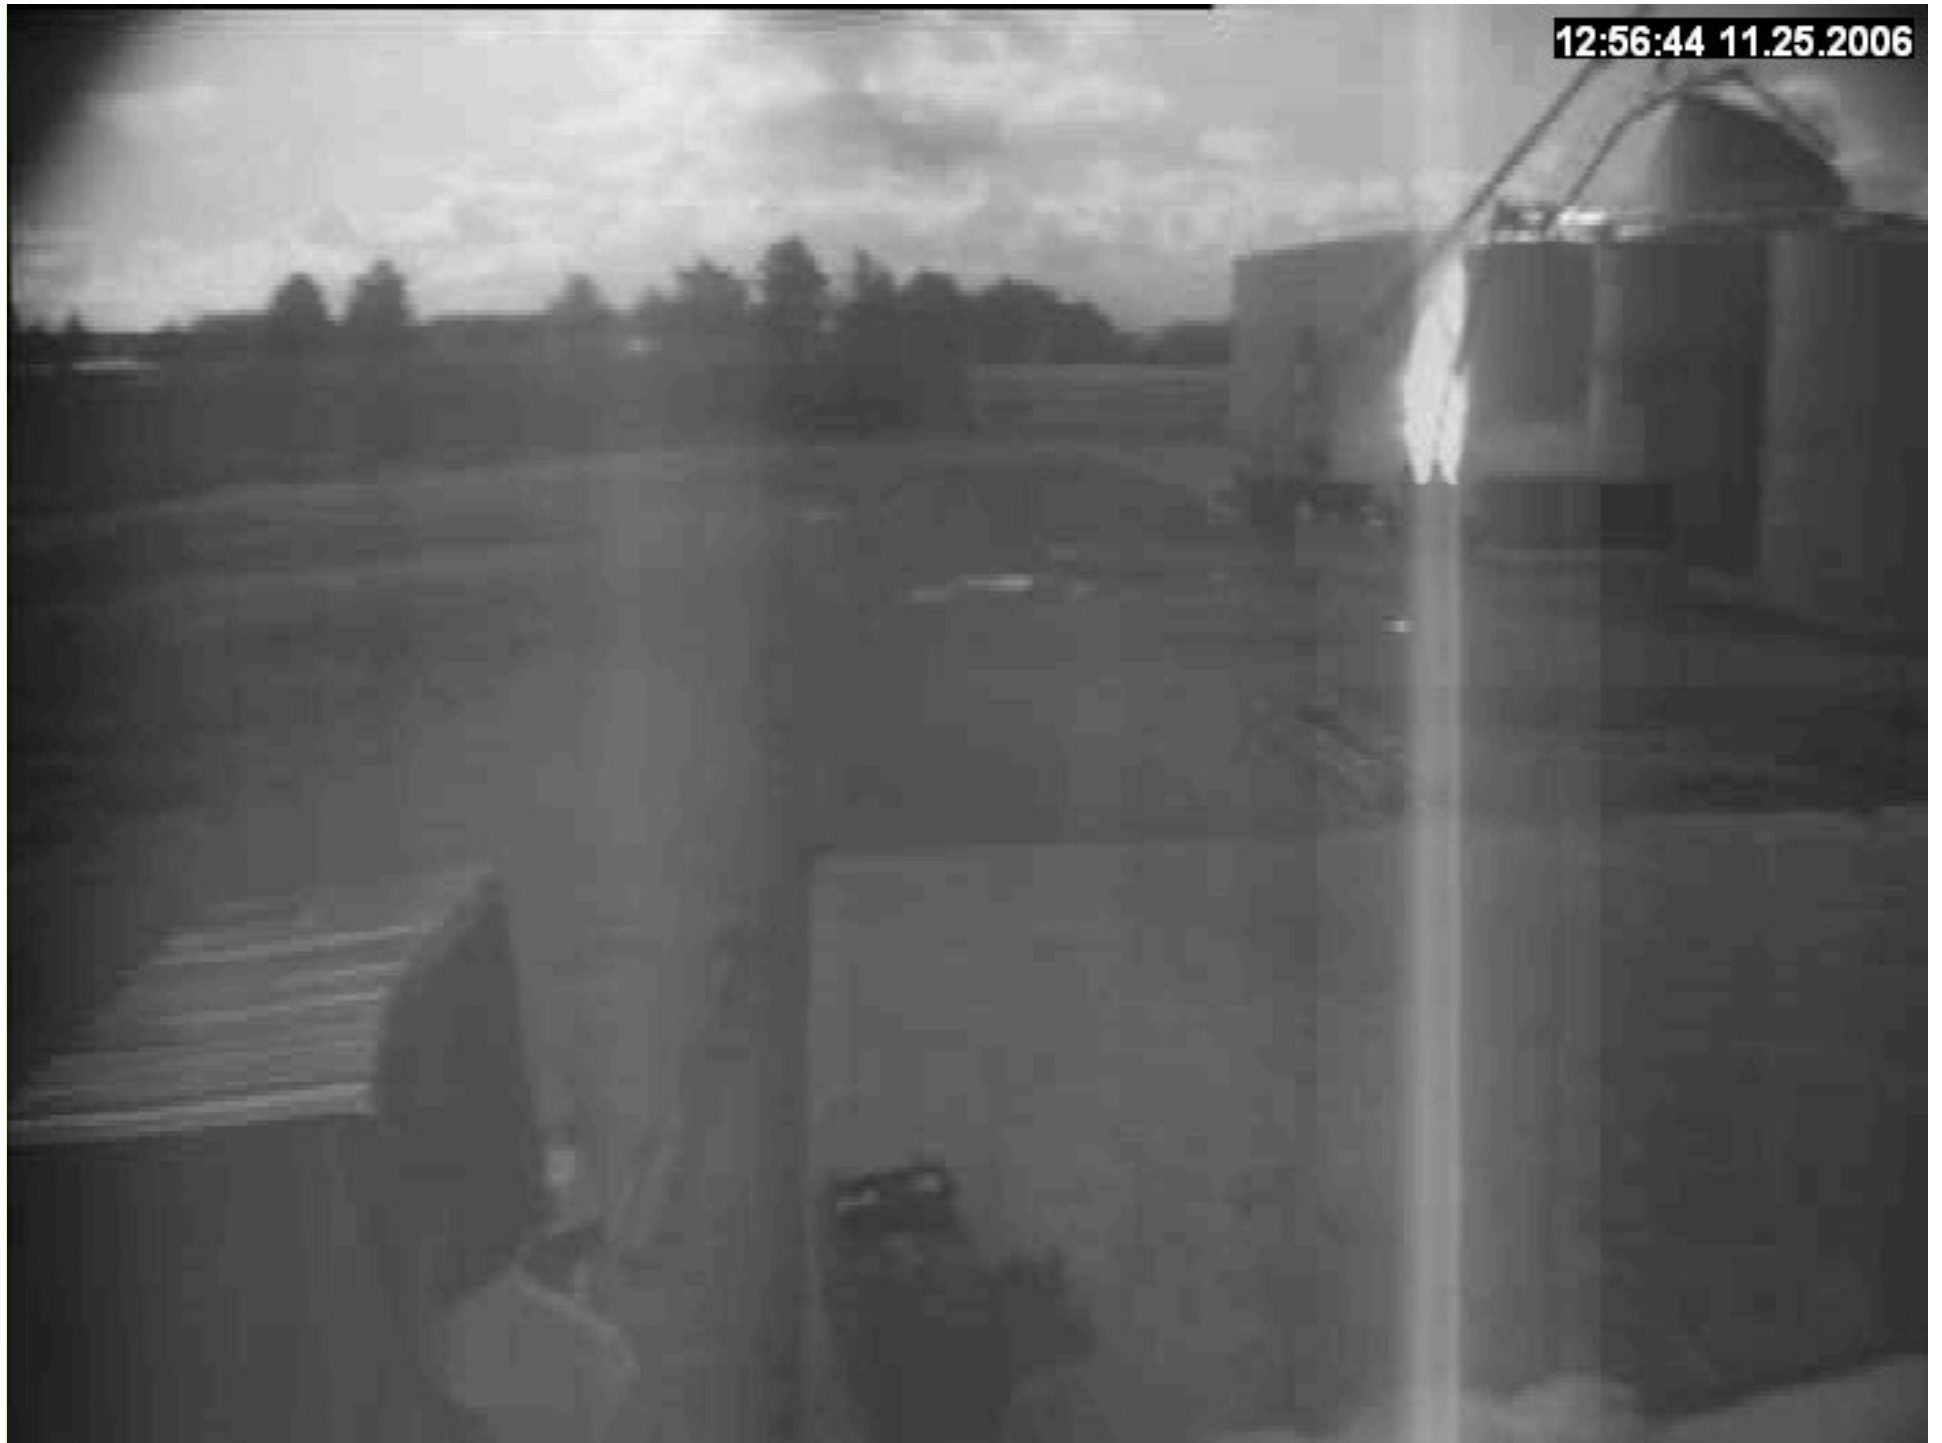
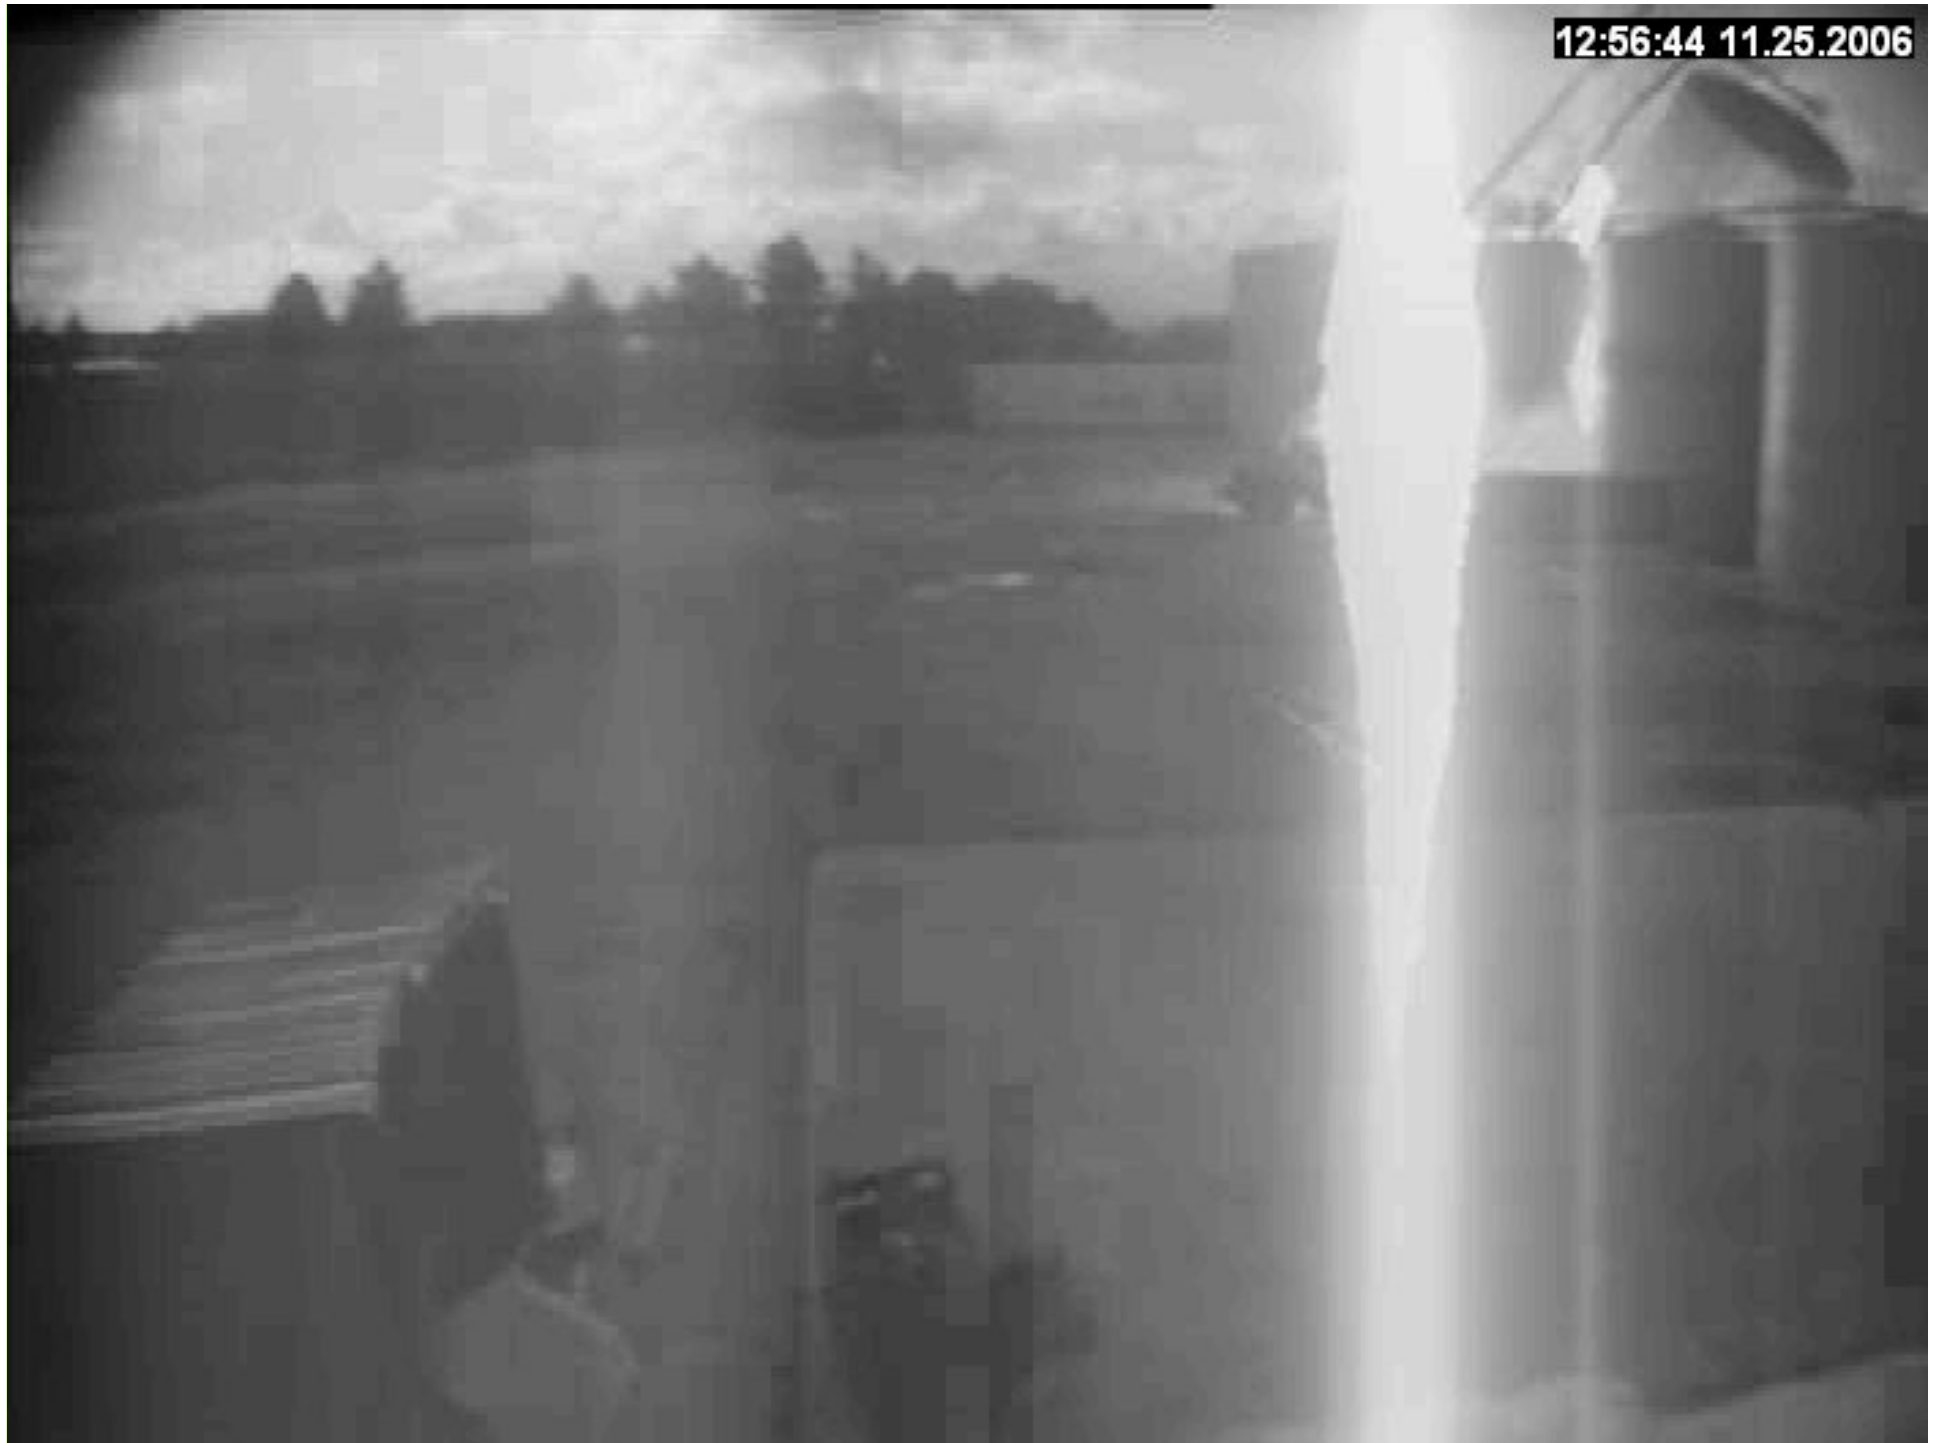
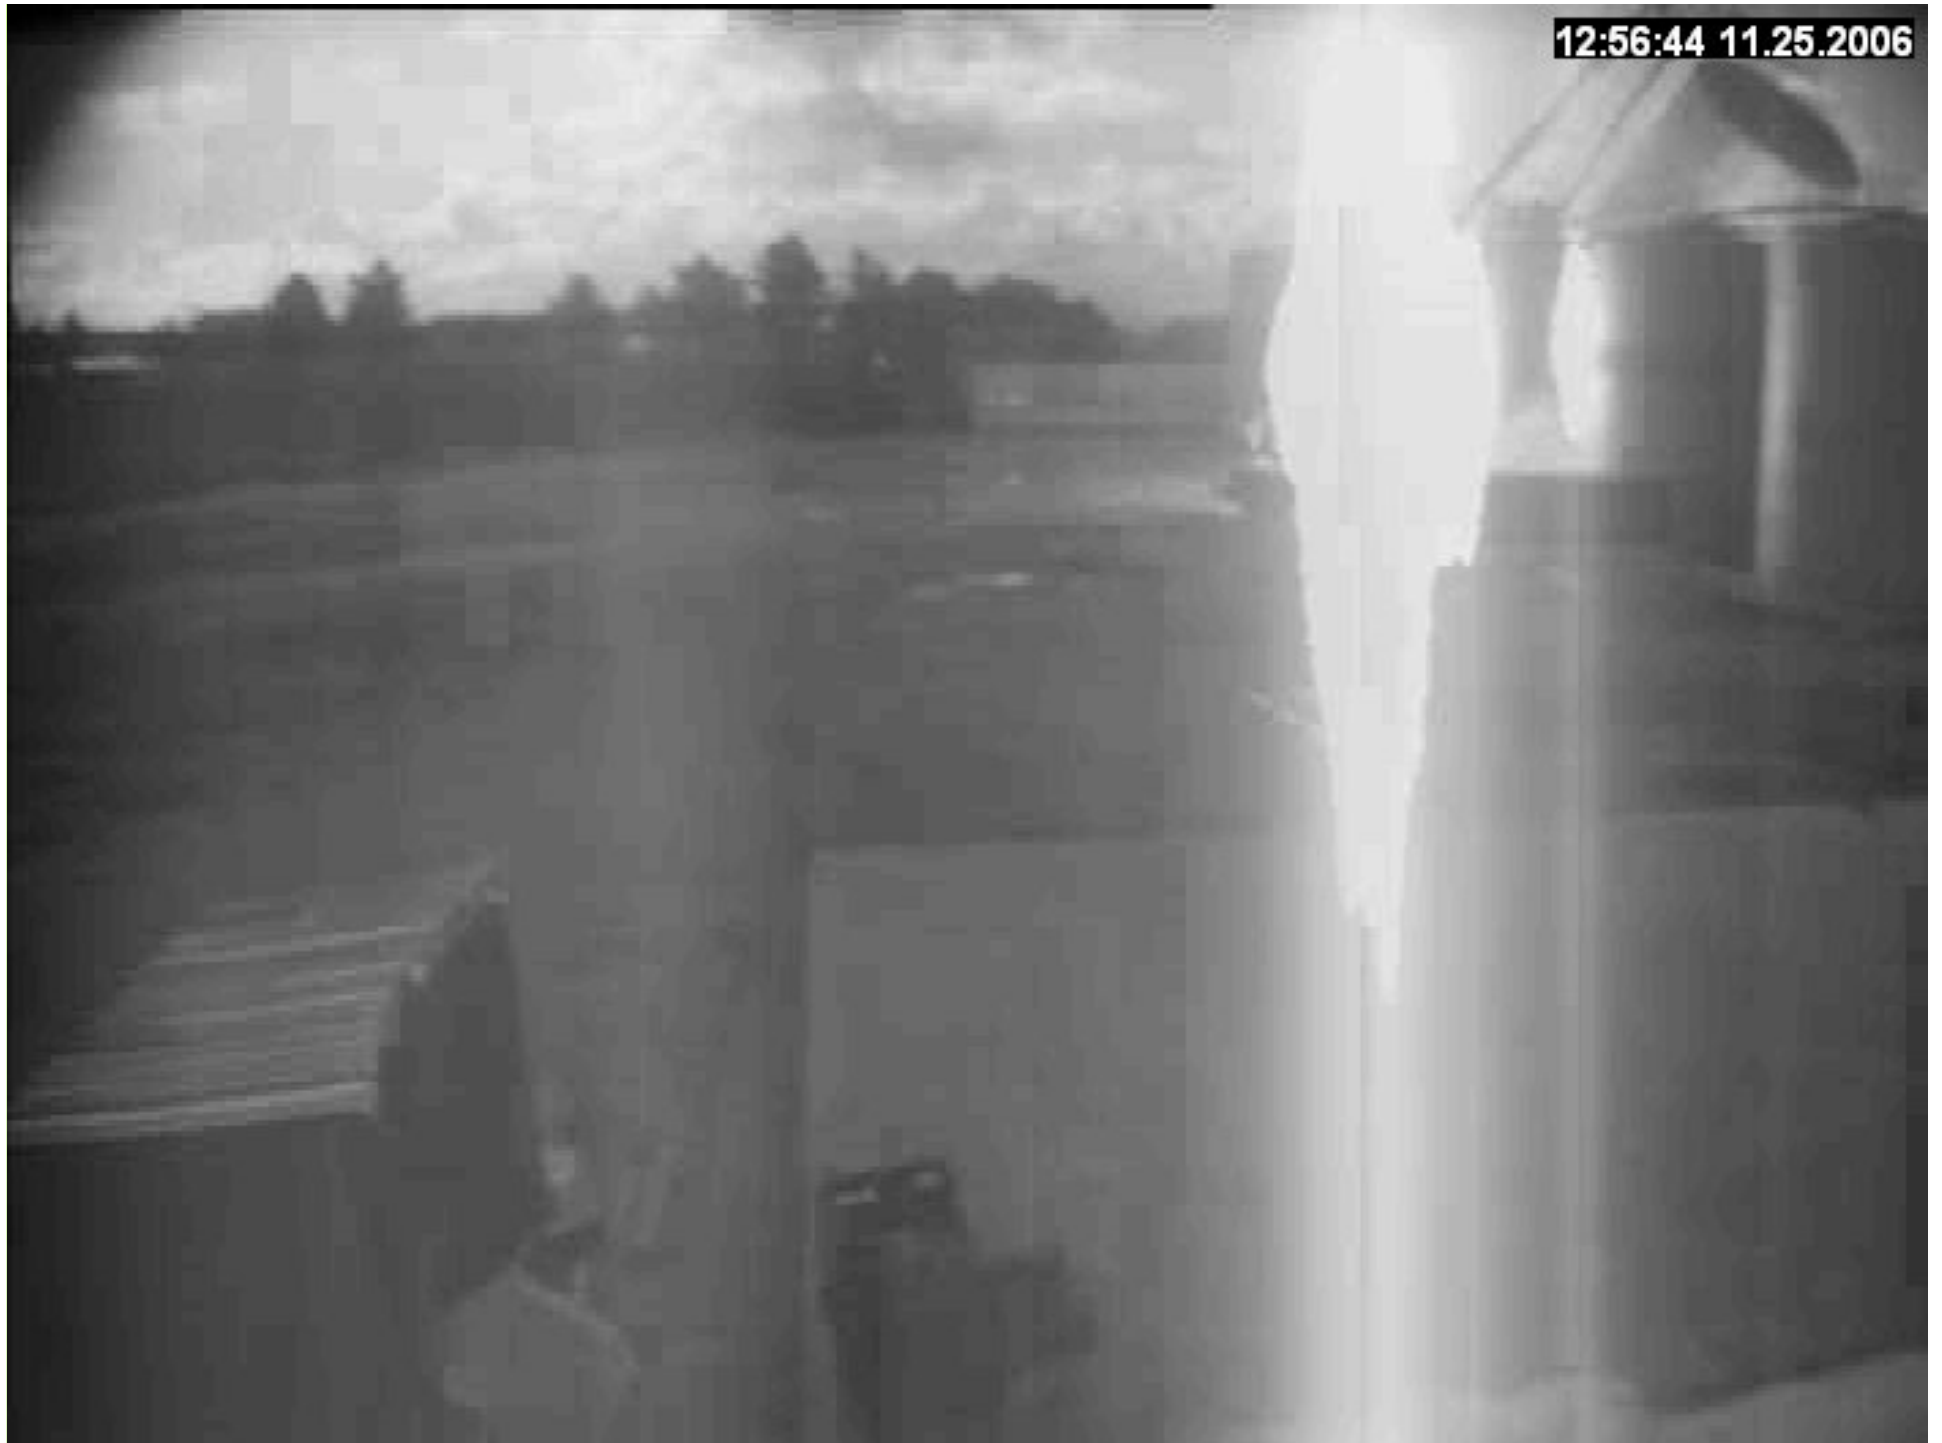
- On Nov. 25, 2006 five workers of a subcontractor firm were realizing a structure of footbridges on the roof of the tanks N° 93 to 107.
- Works started 4 days before, at the moment of the accident the footbridges were already installed on tanks from n° 100 to 107.
- At 12.56 tank n° 95 exploded.
- At that time four out of five workers were on the tank roof.
- The tank n°95 rose up of about 10 m and then fell down almost in the same position.
- A wide pool fire spread in the tank park.

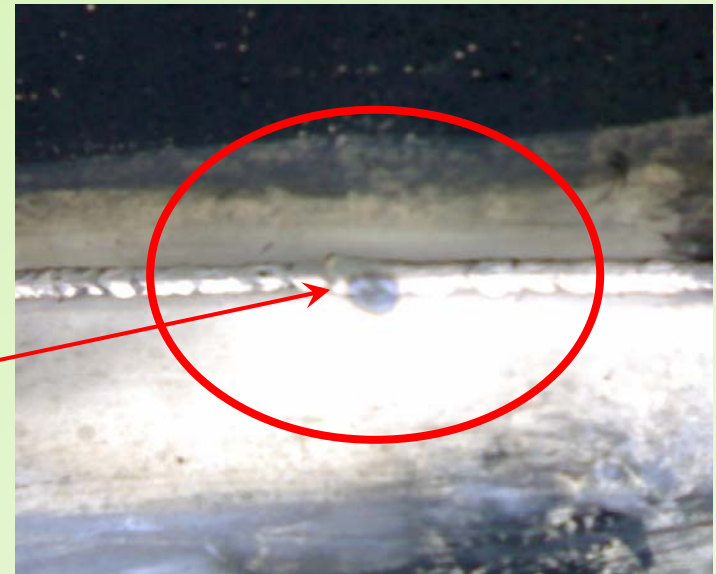
Tank # 95: Weld bead on top of the tank (outside).

Overheating (at least 750 °C) fingerprint inside the tank.

One worker found still holding the clamp of the welding machine

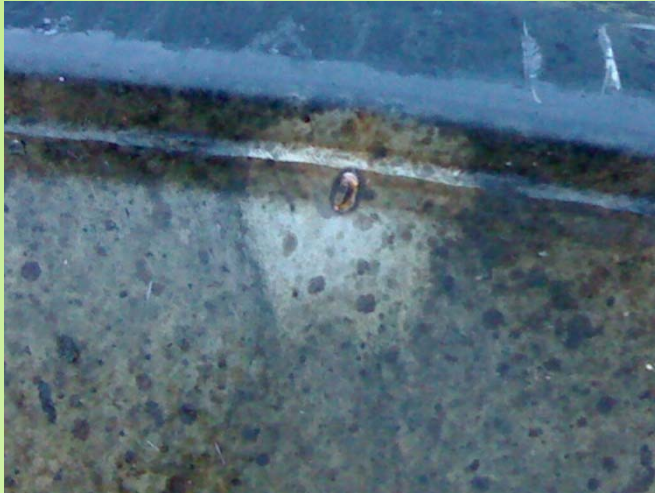
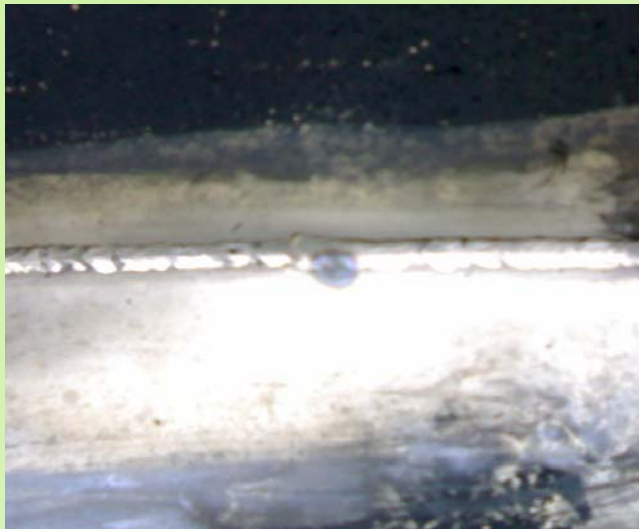
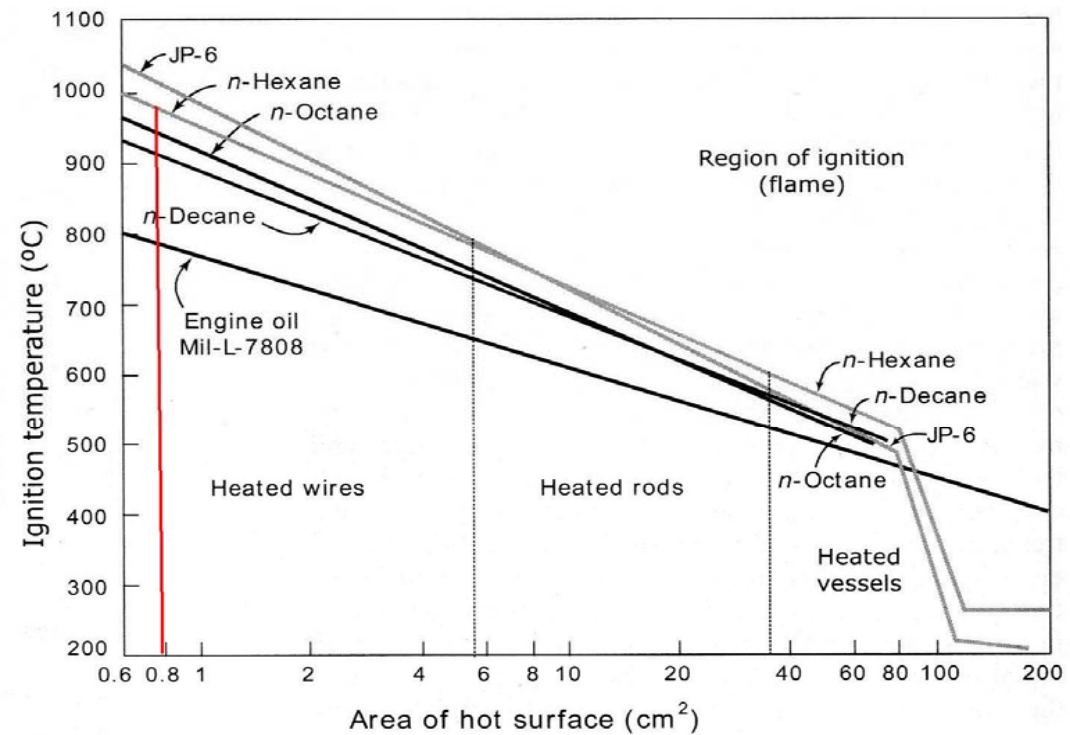
**Figure 71** Ignition of vapors from hot surfaces: the effect of surface area

The overheating fingerprint found on the roof of tank N° 95 do not indicate an effective ignition source.
