# **INVESTIGATING THE CAUSES OF FIRE**

Causes and dynamics of the multiple explosion occurred in the tank park of a plant that processed raw pomace oil to get edible olive oil

**Loris MUNARO - Luca MARMO**  
**Norberto PICCININI - Paola RUSSO – Gennaro RUSSO**

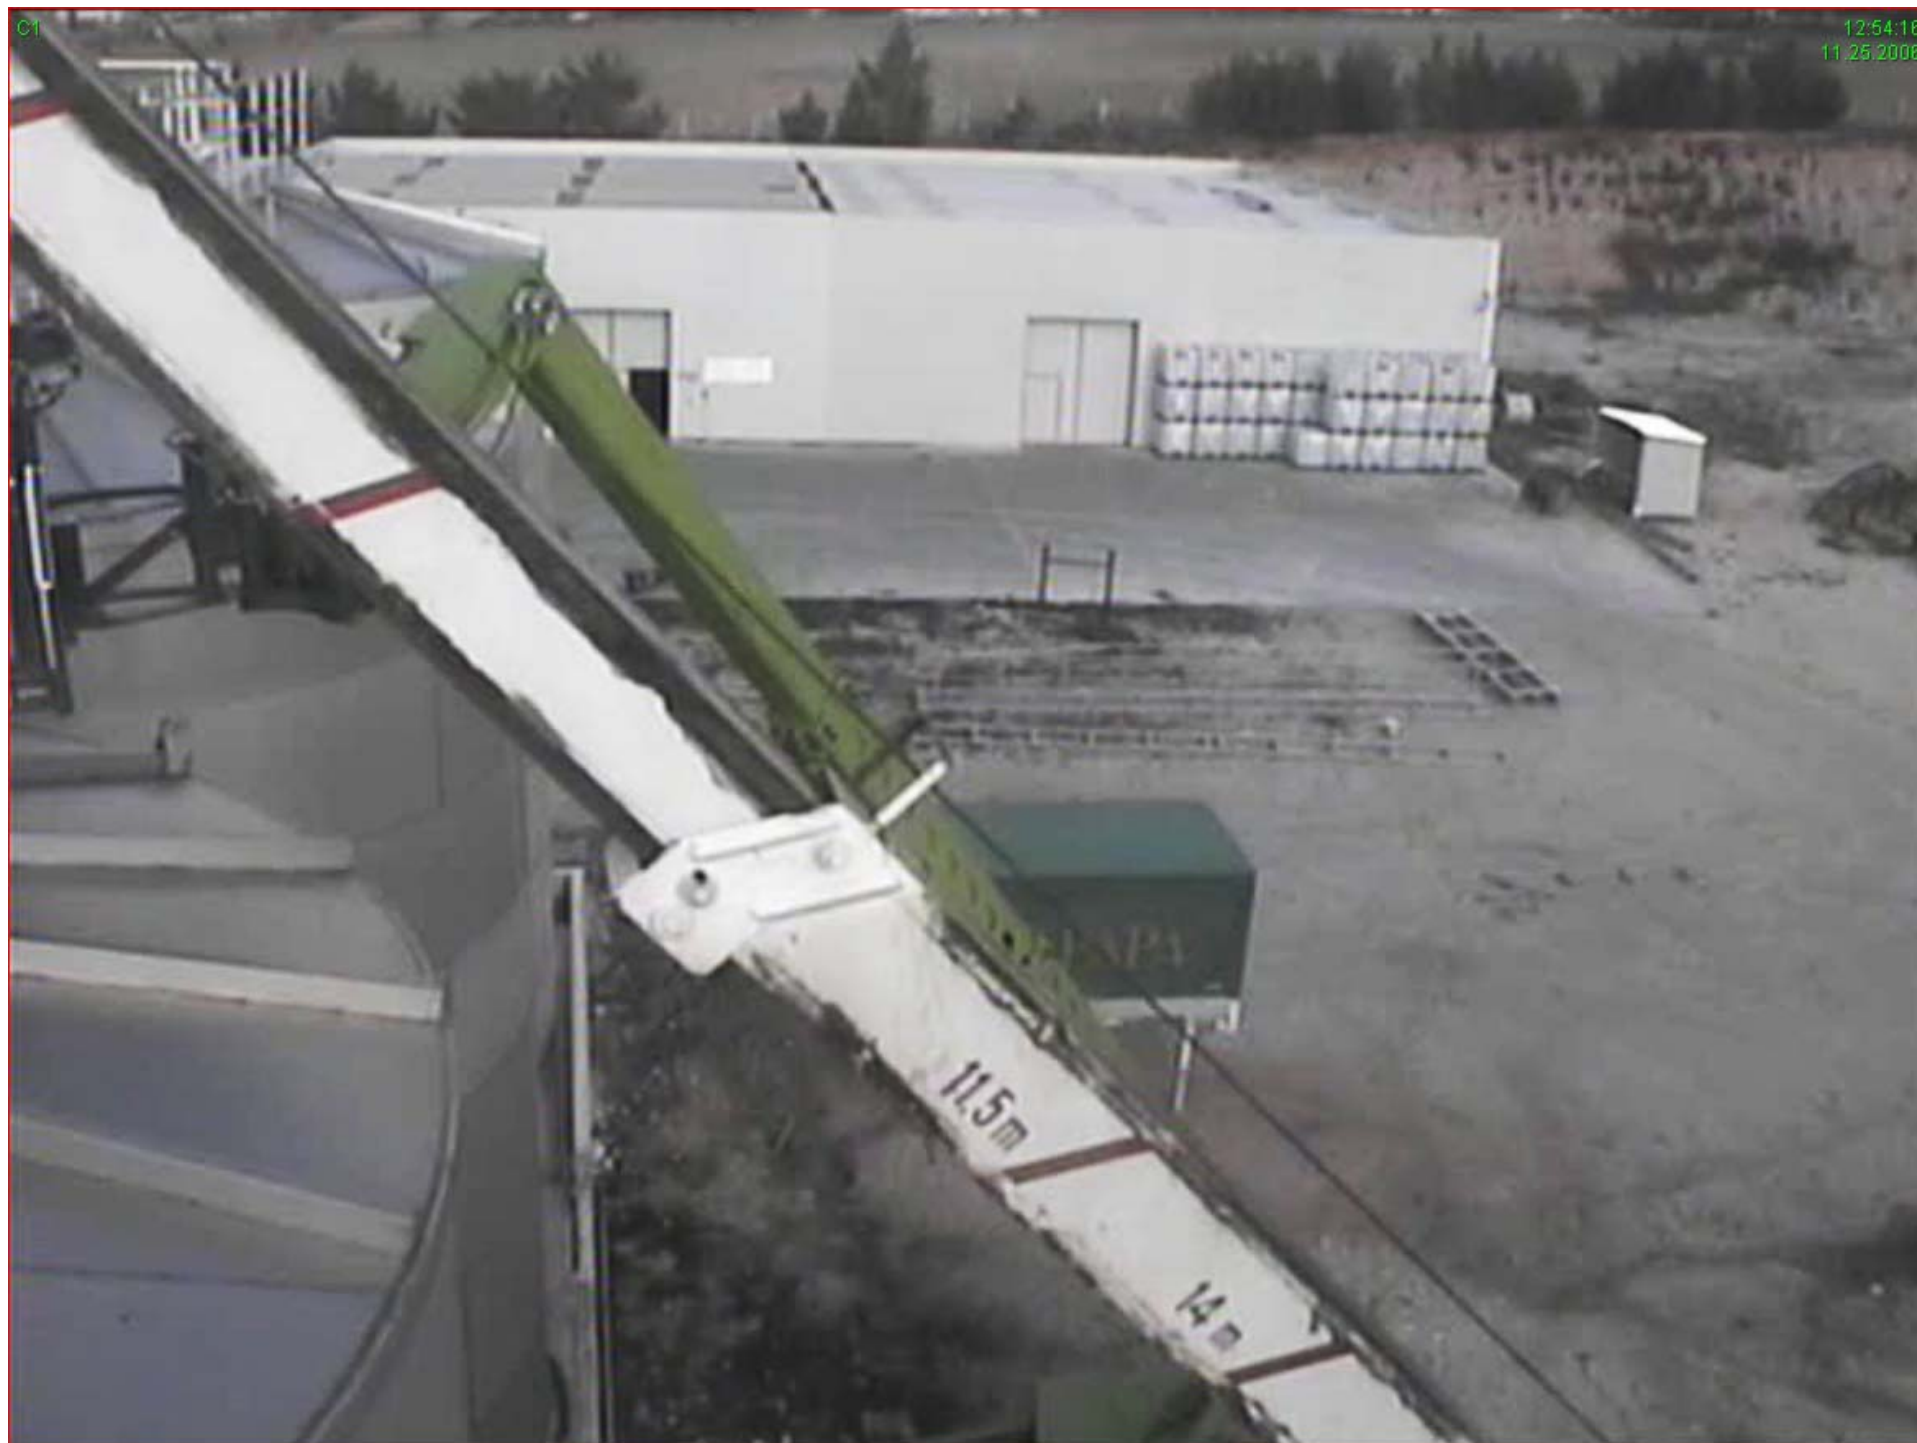
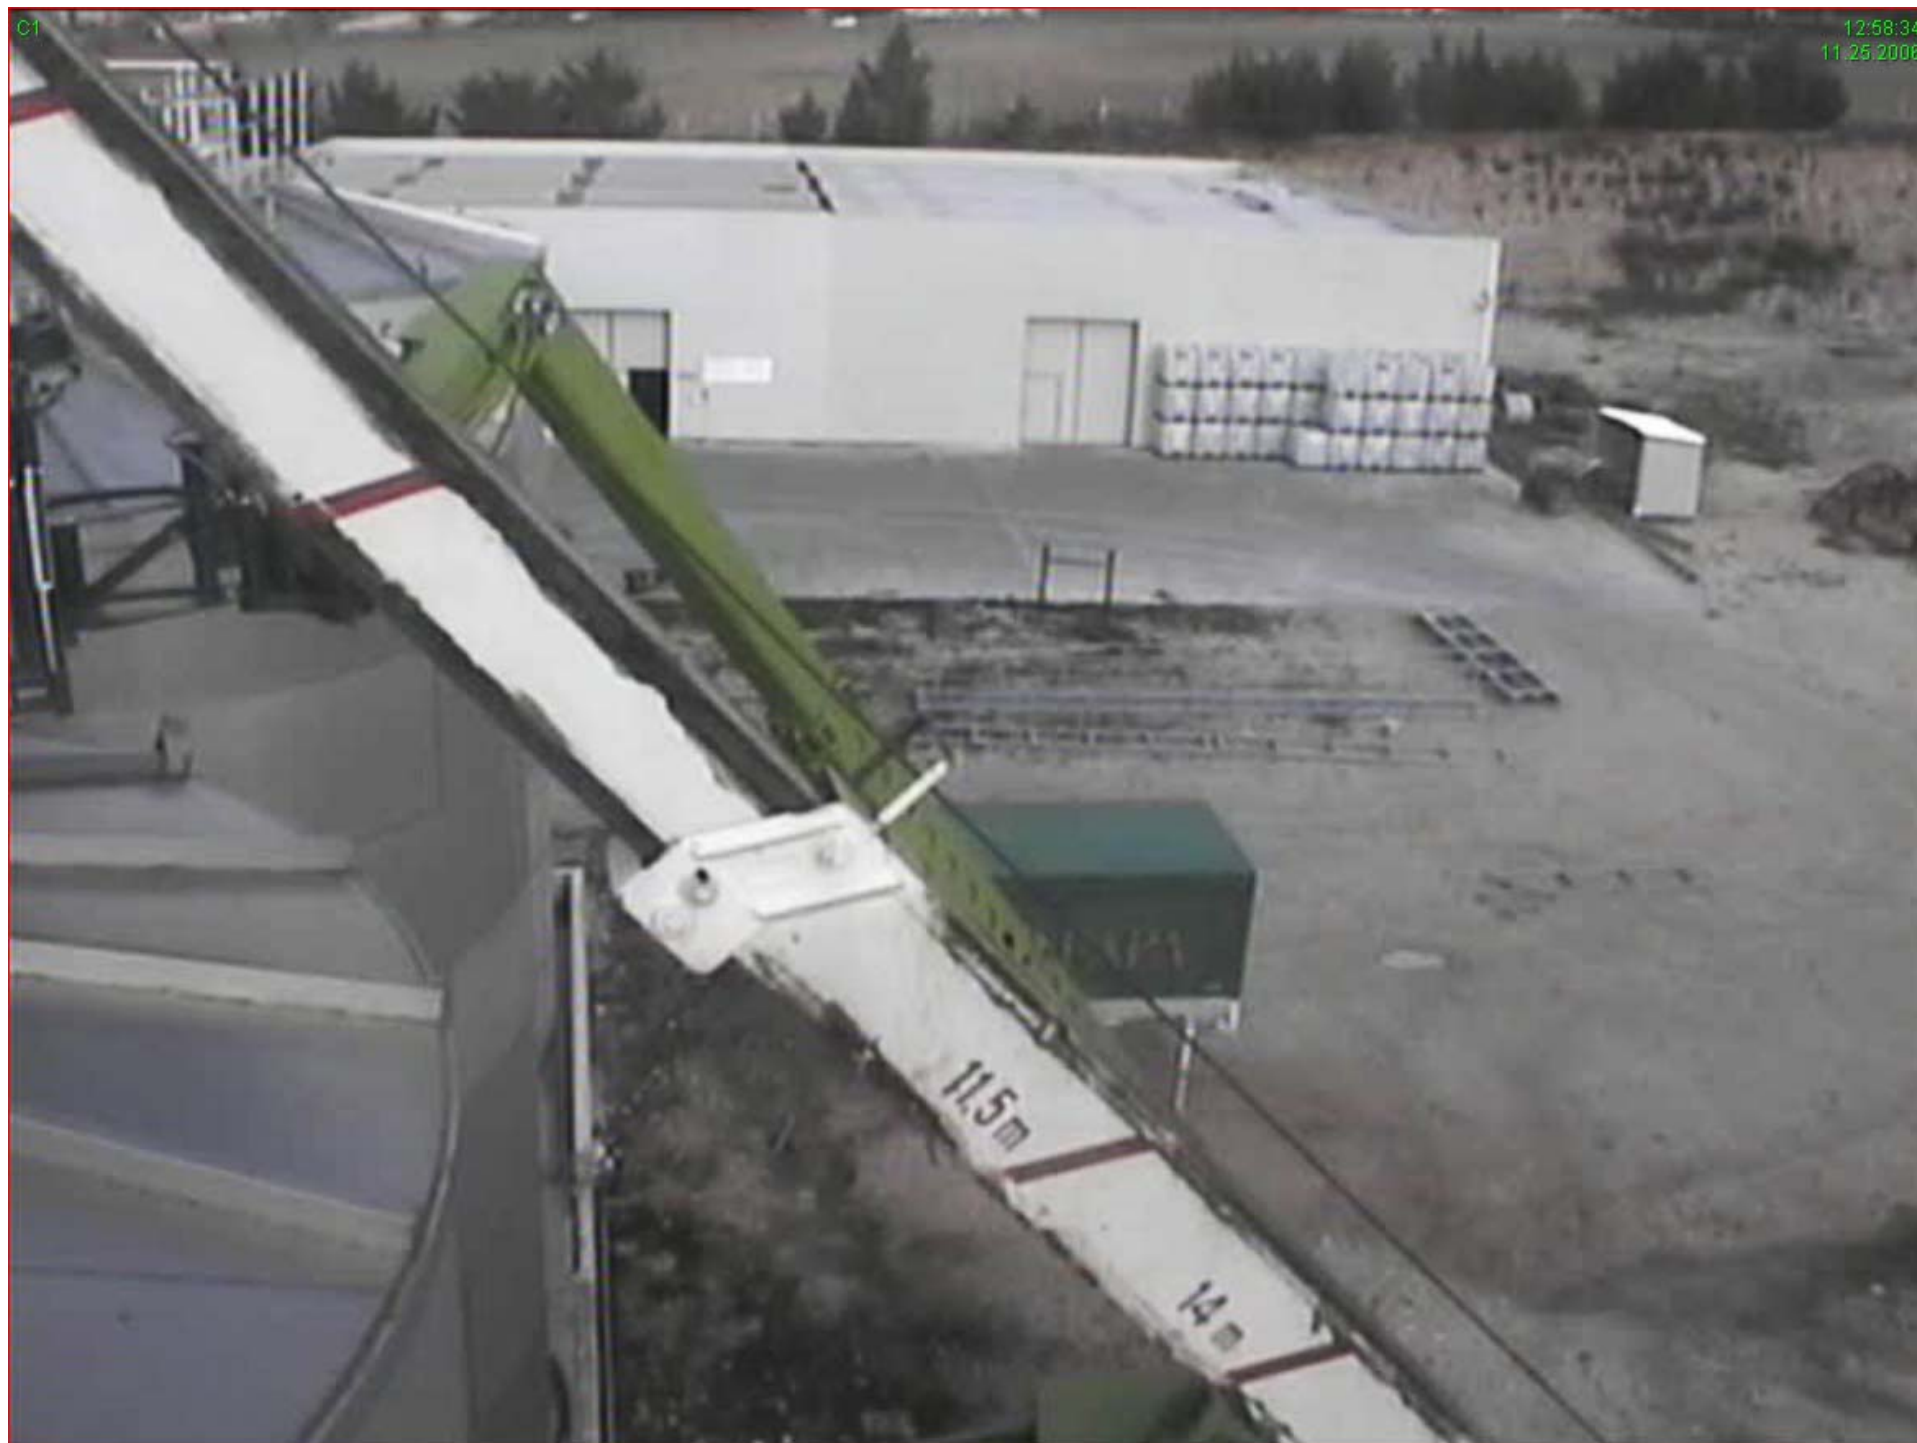
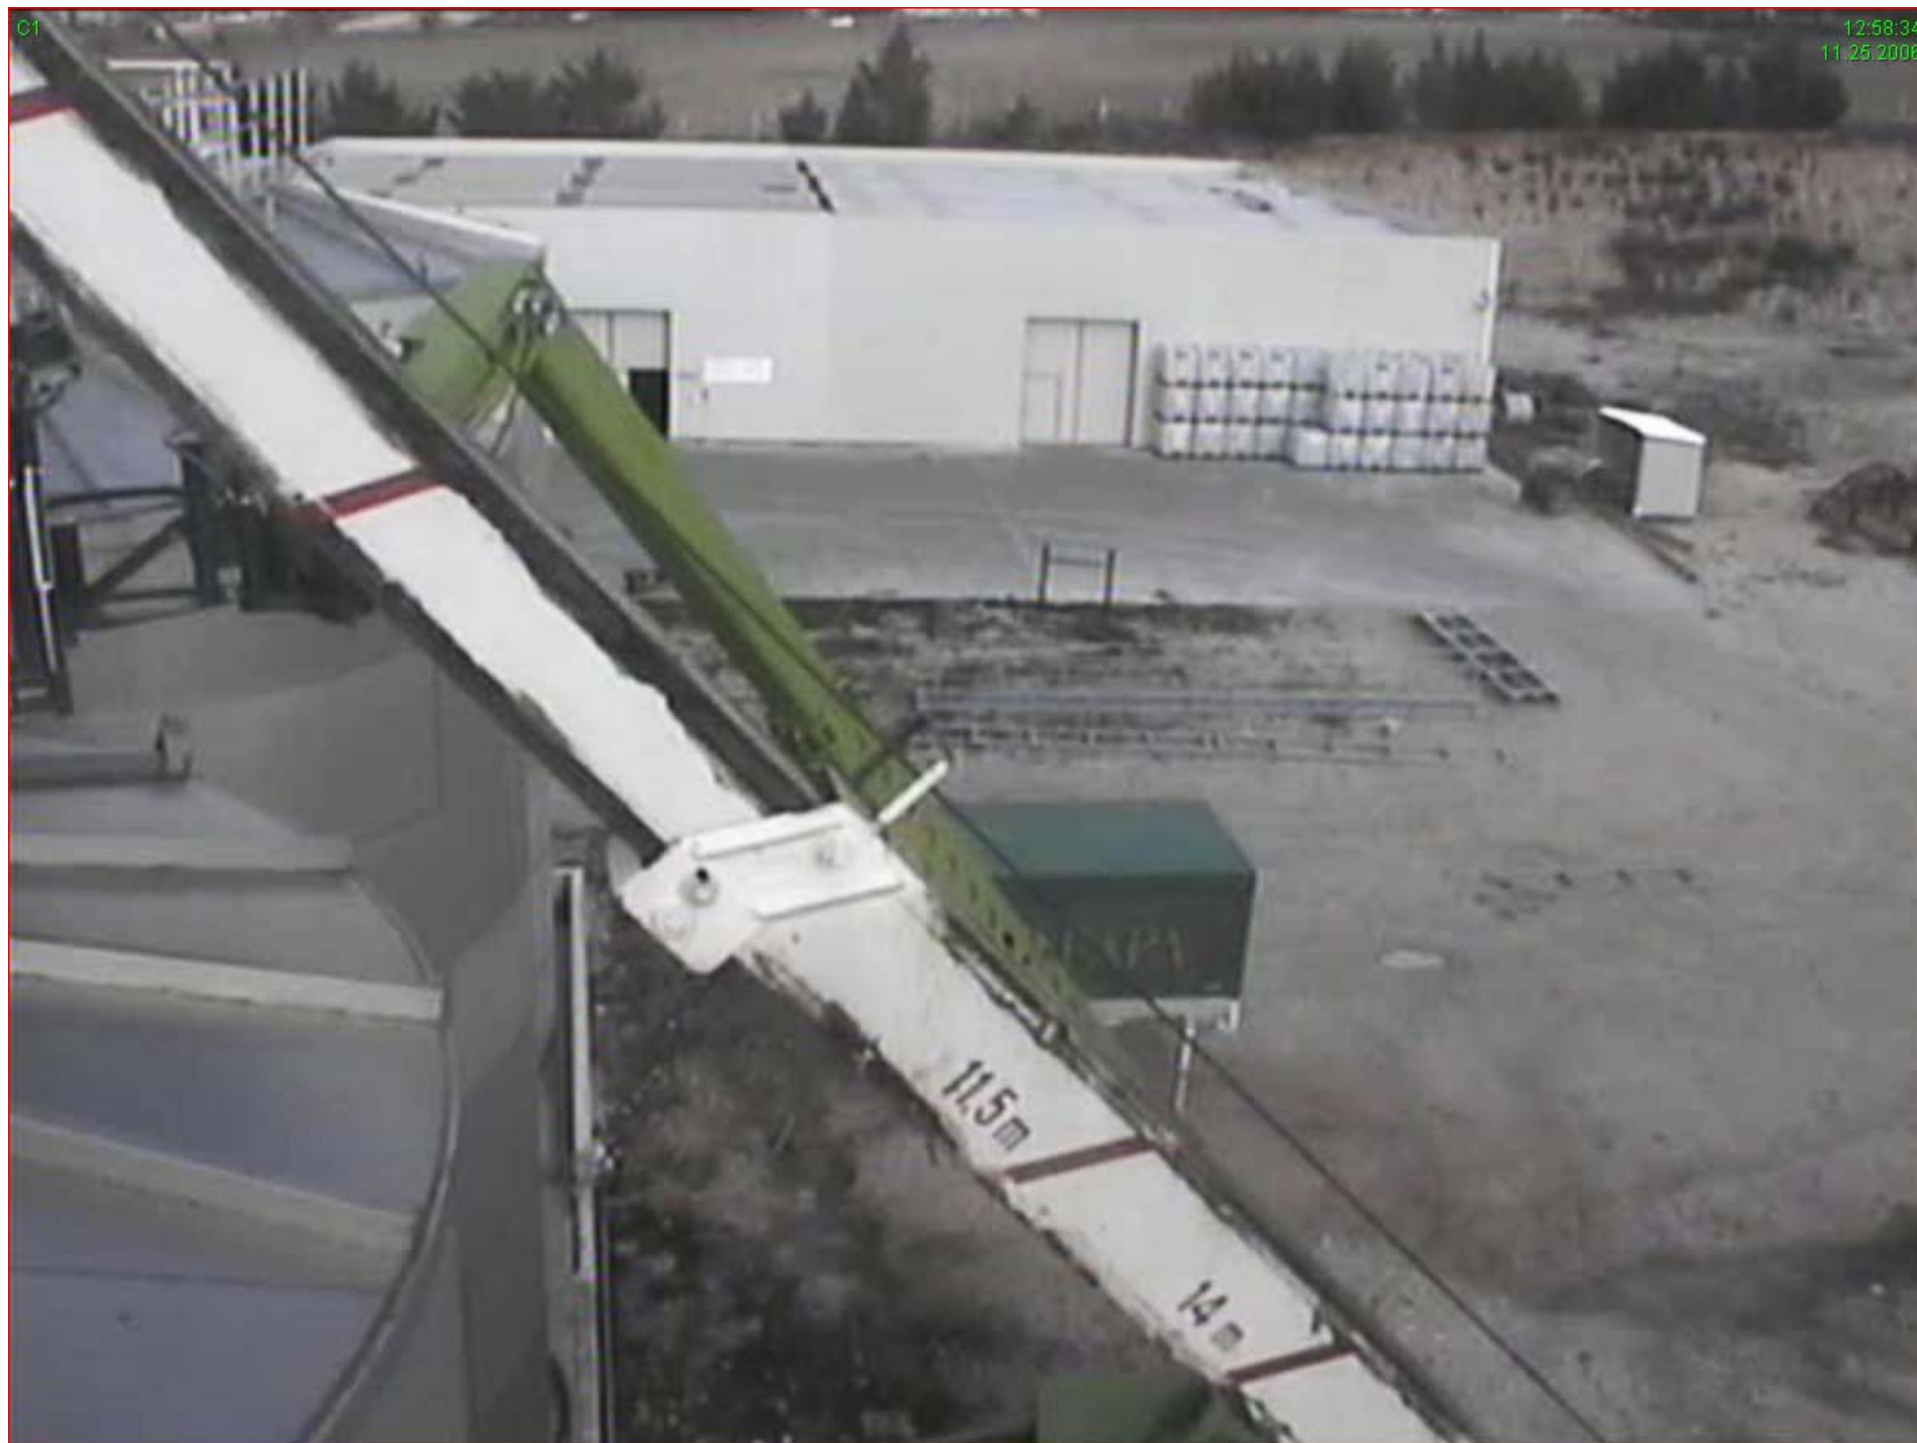
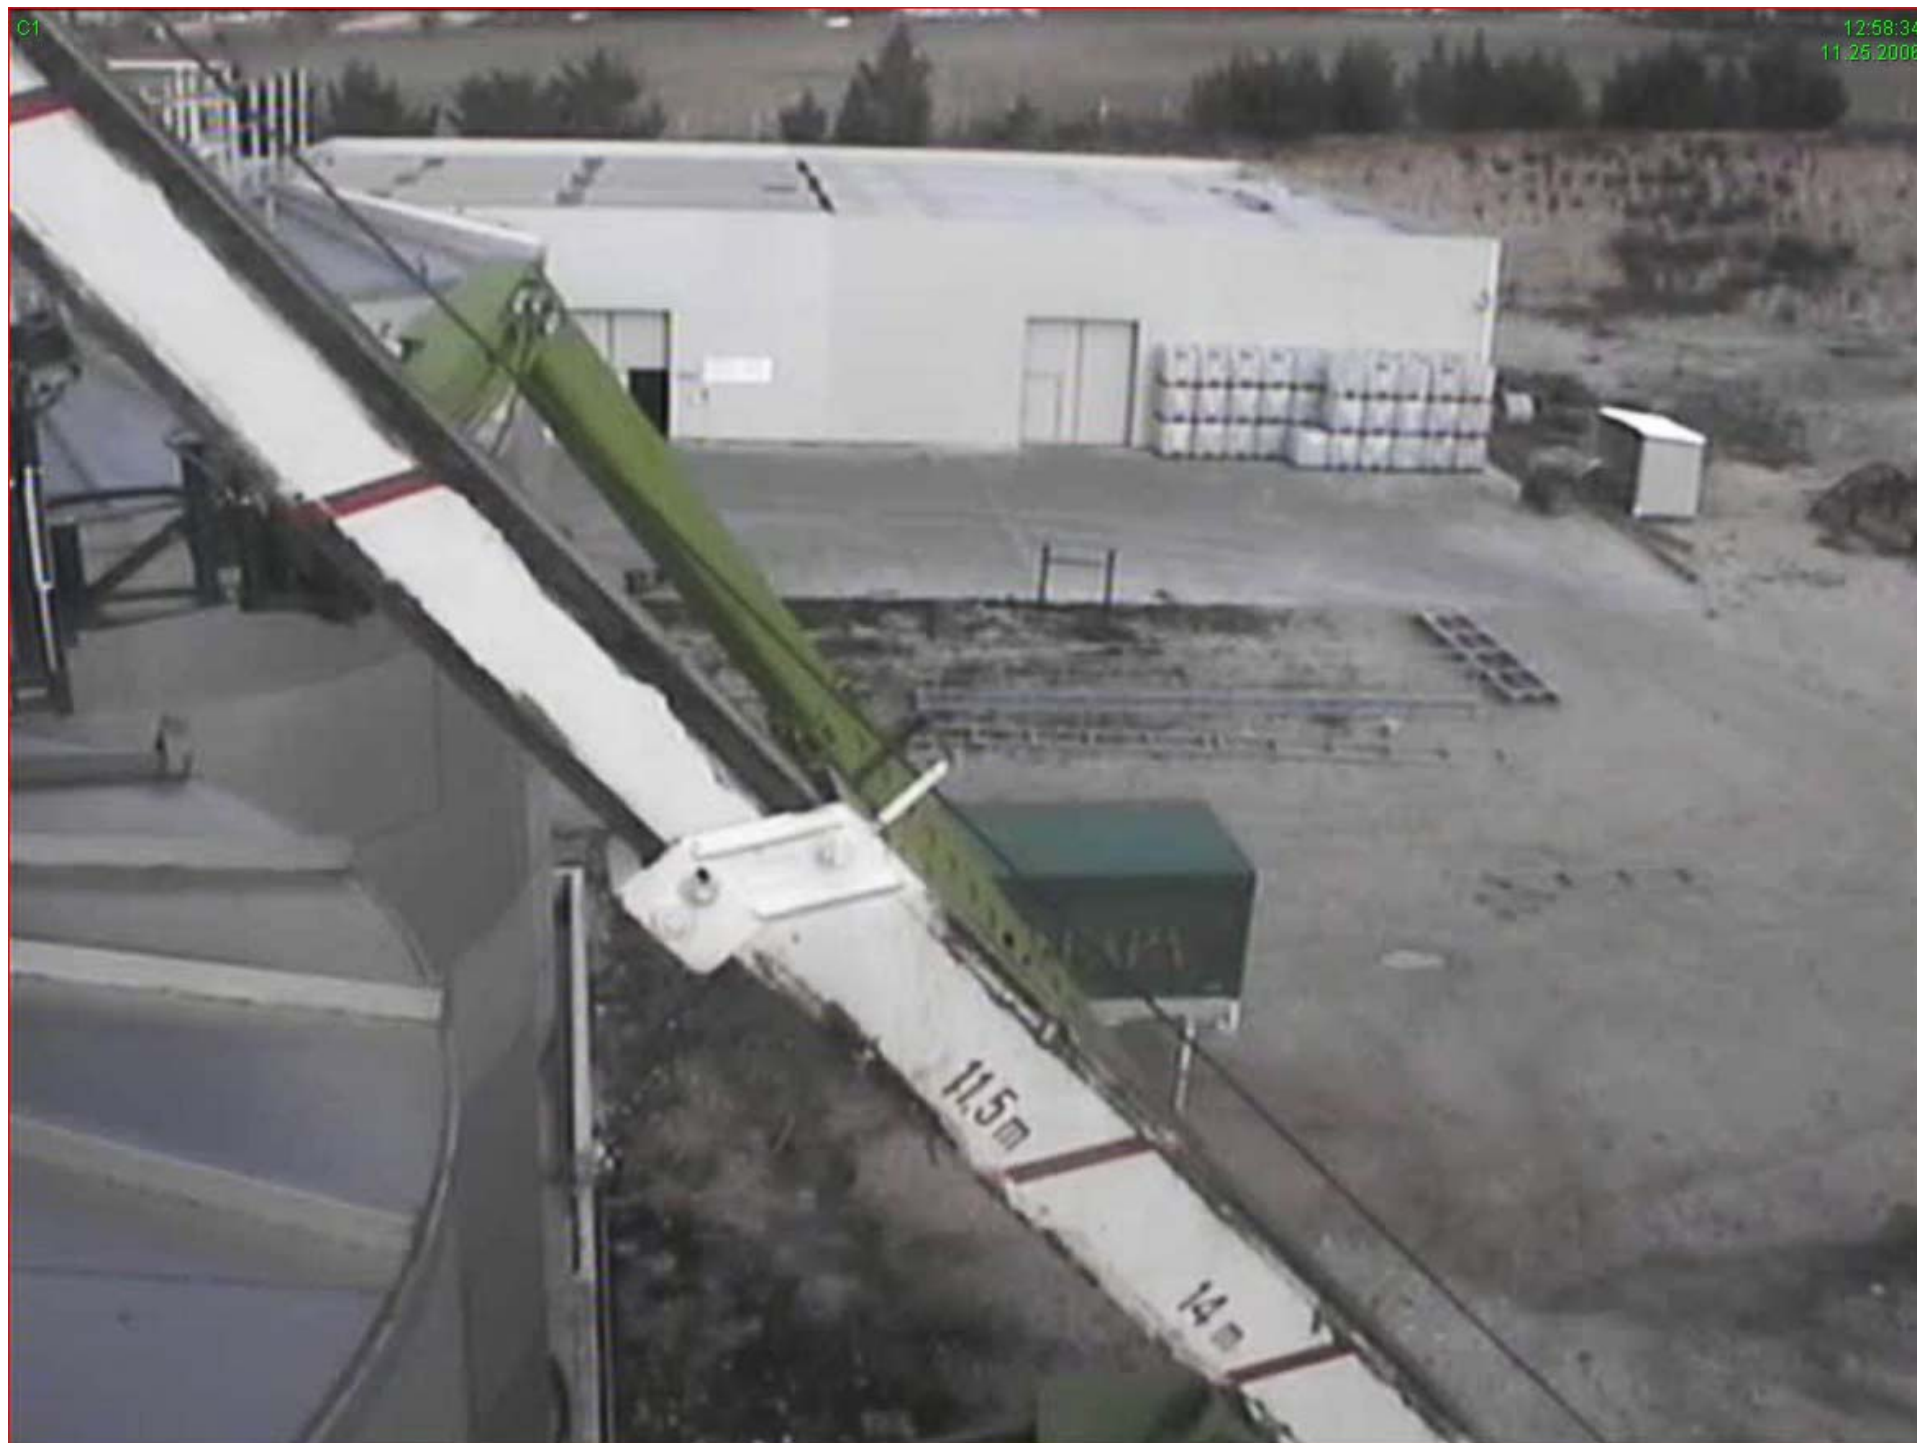
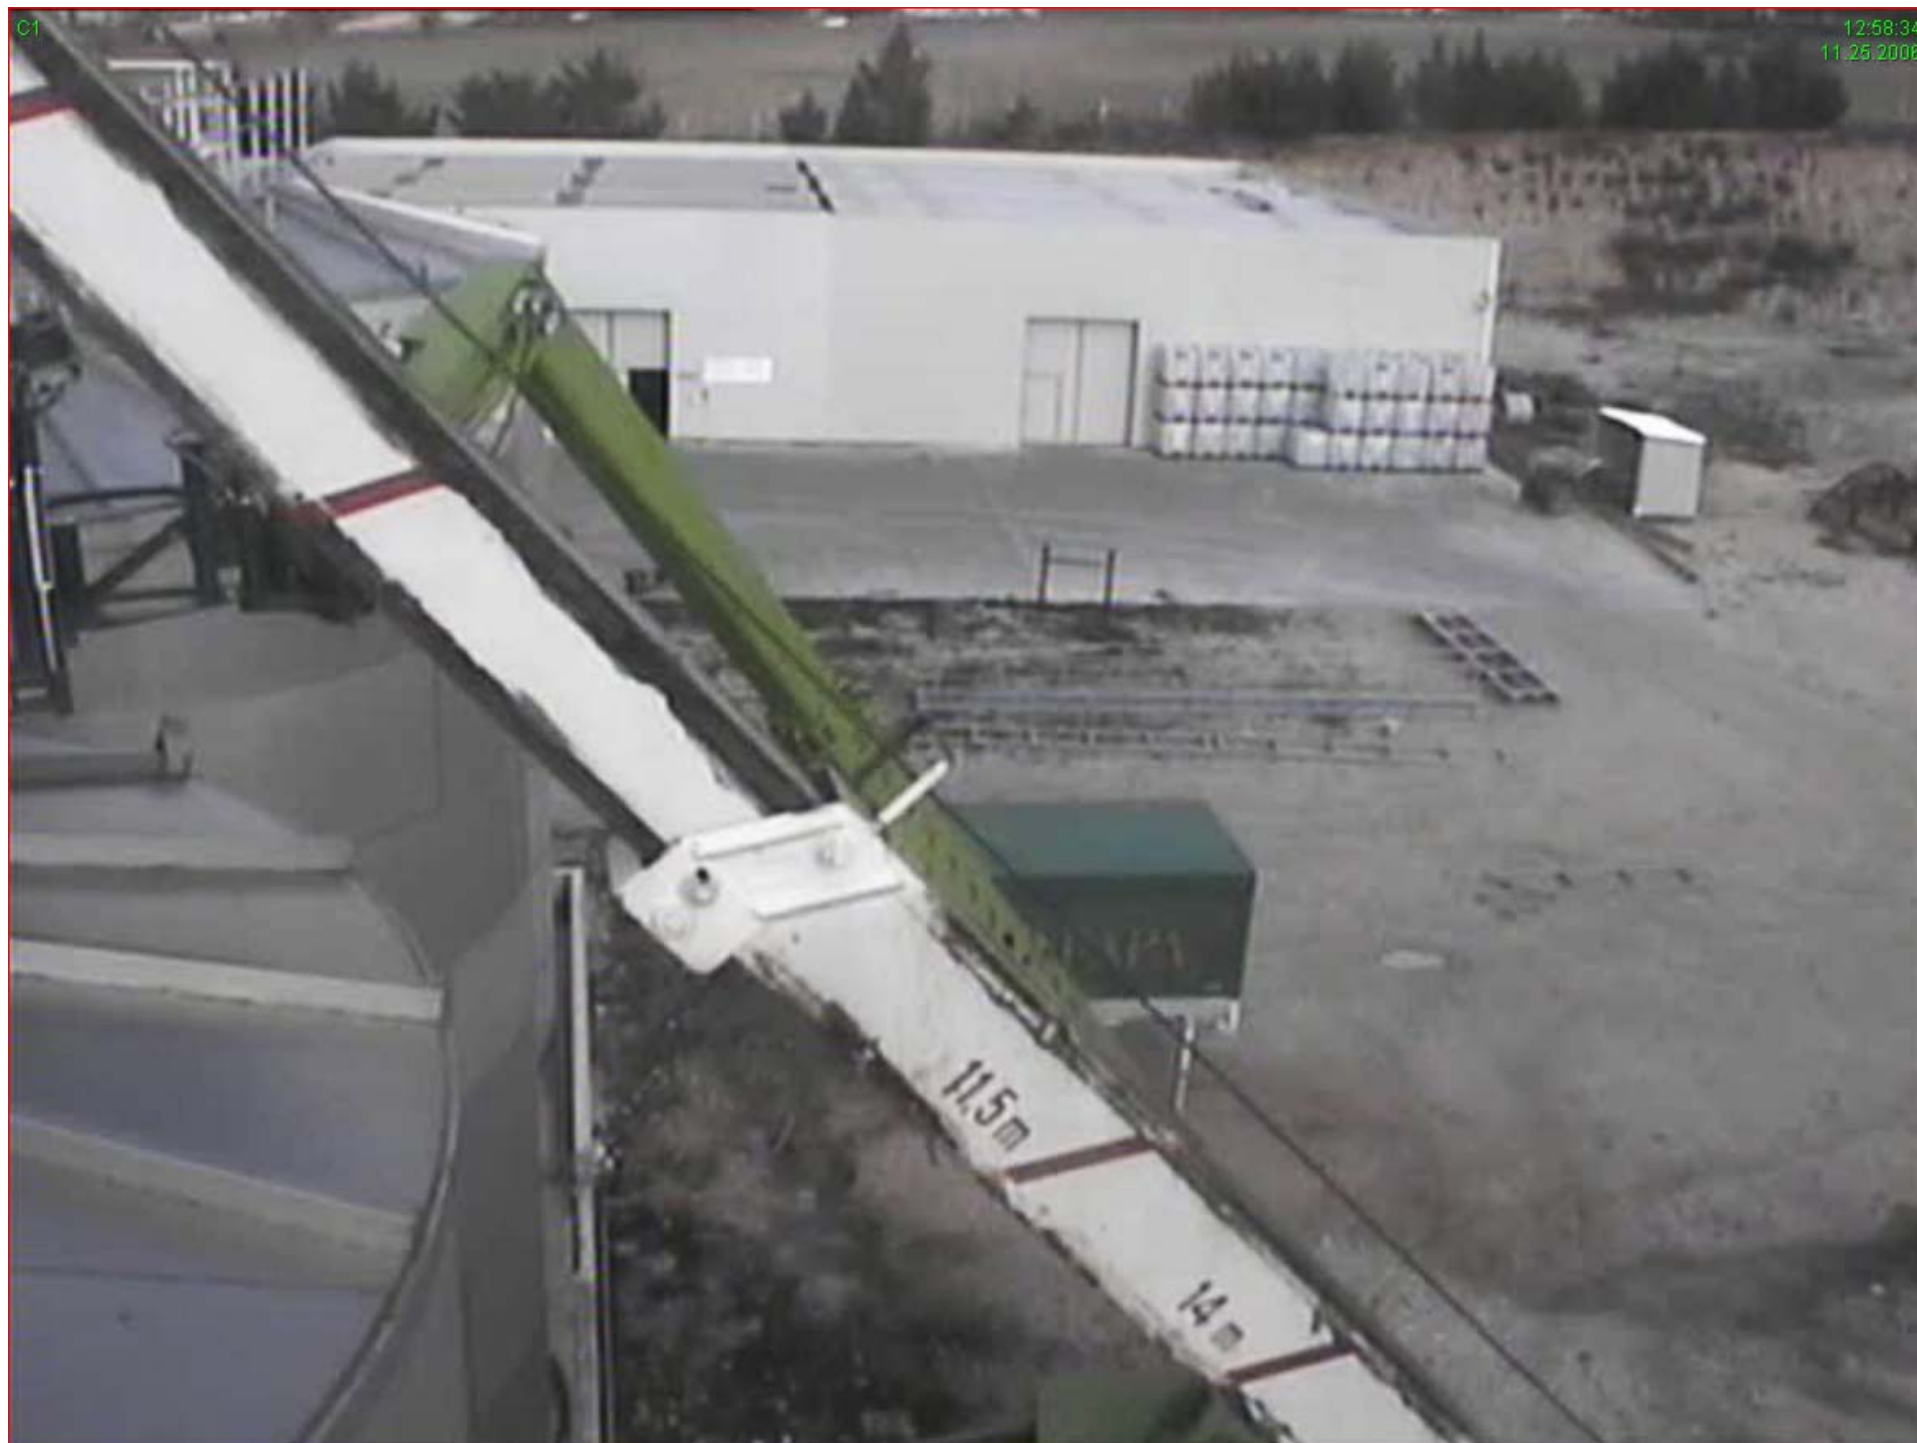
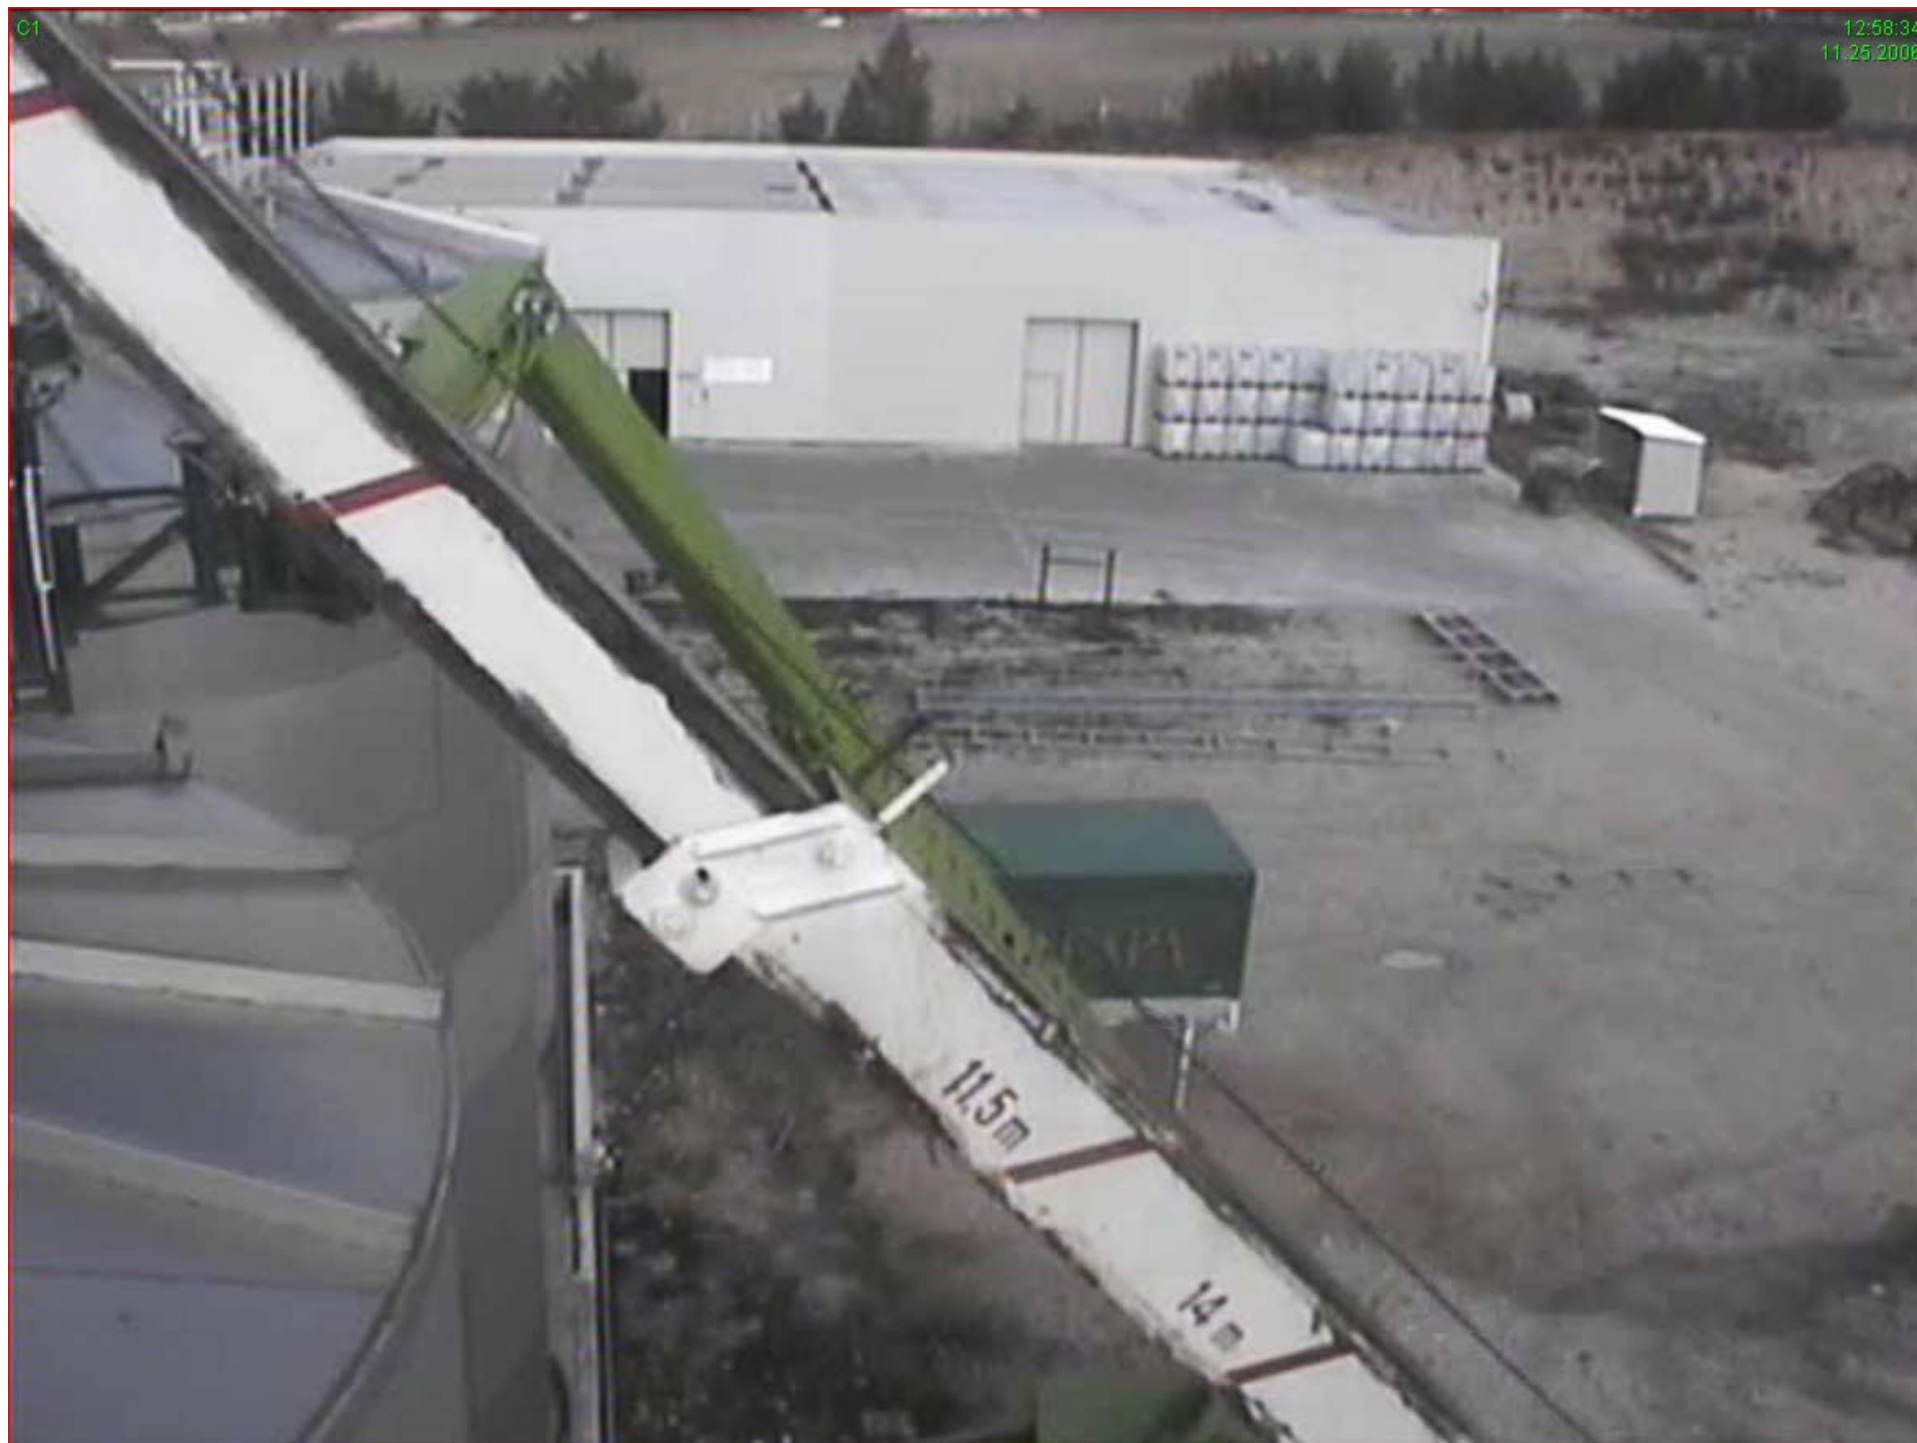
The fishing rod theory

*“By the vision of the movie it is clear as the arm of the crane first operates a traction (the rope is moving ever closer to the arm), then suddenly the rope is loosened.*

*Notice even the curls (frame 12) due to the sudden loosening when the tank is uprooted from the base and rises to one side.*

*The oil spills through the gash, the tear causes sparks which ignite the oil on the ground*

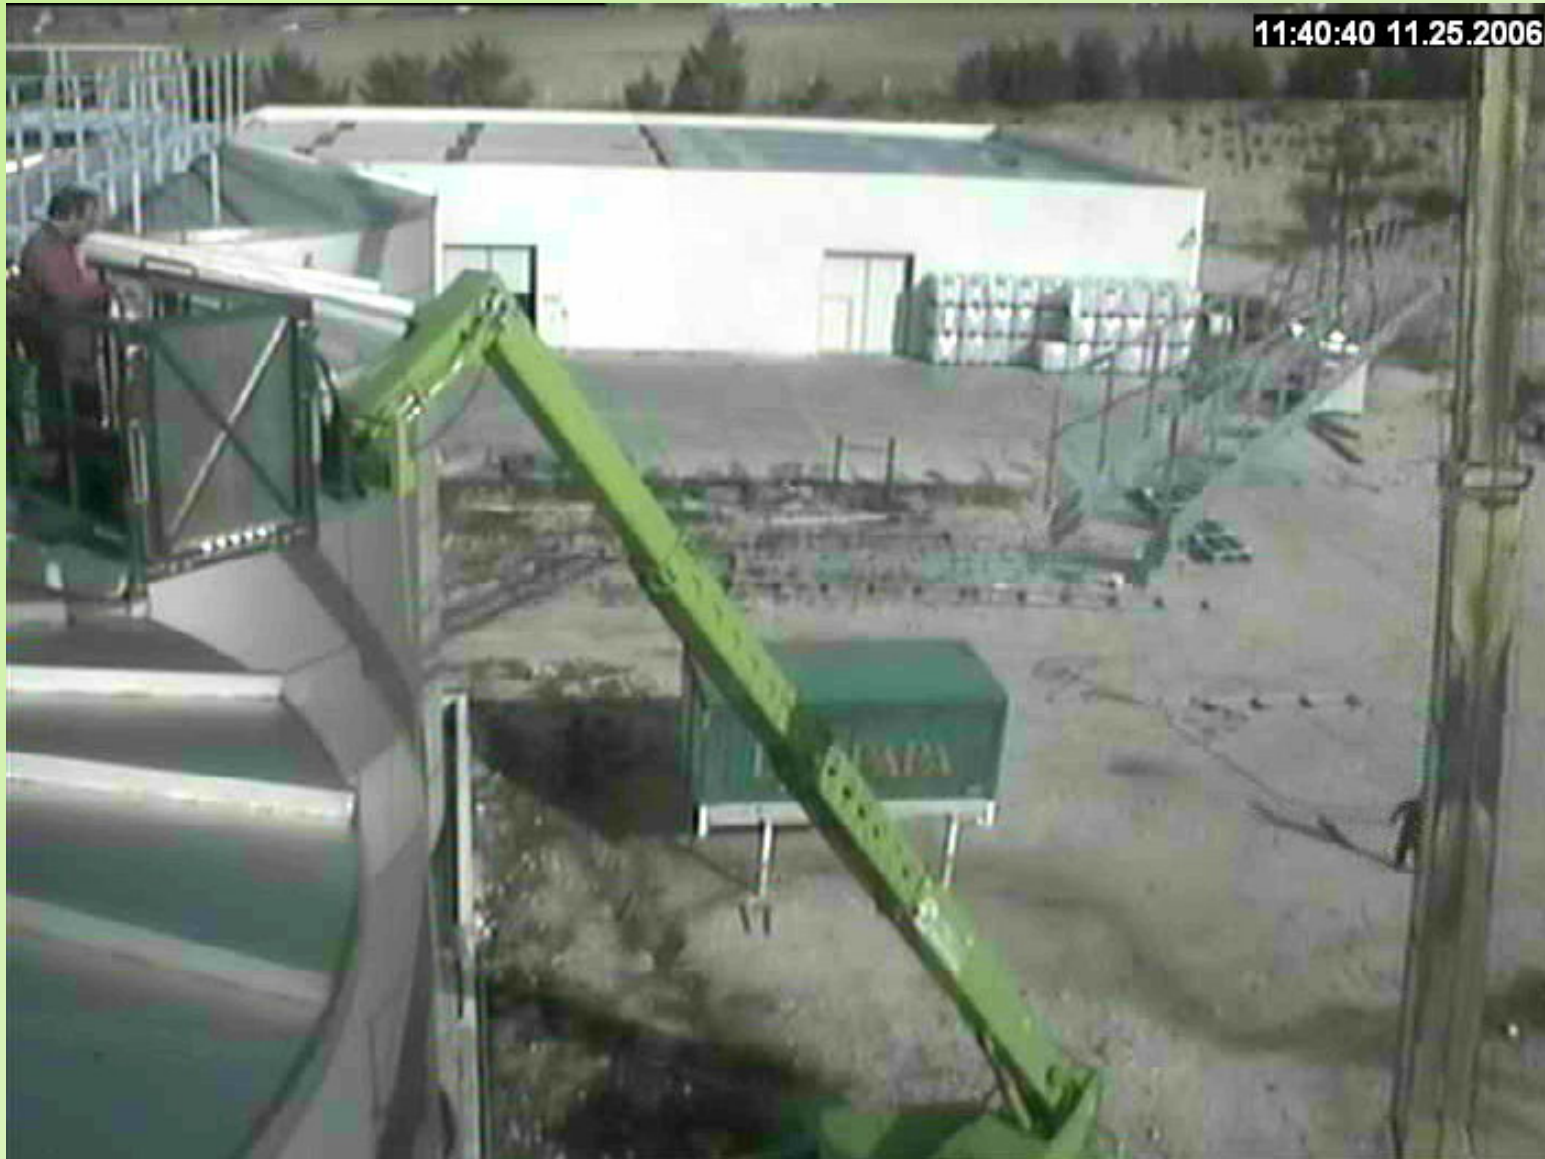
No explosion occurred in tank # 95
